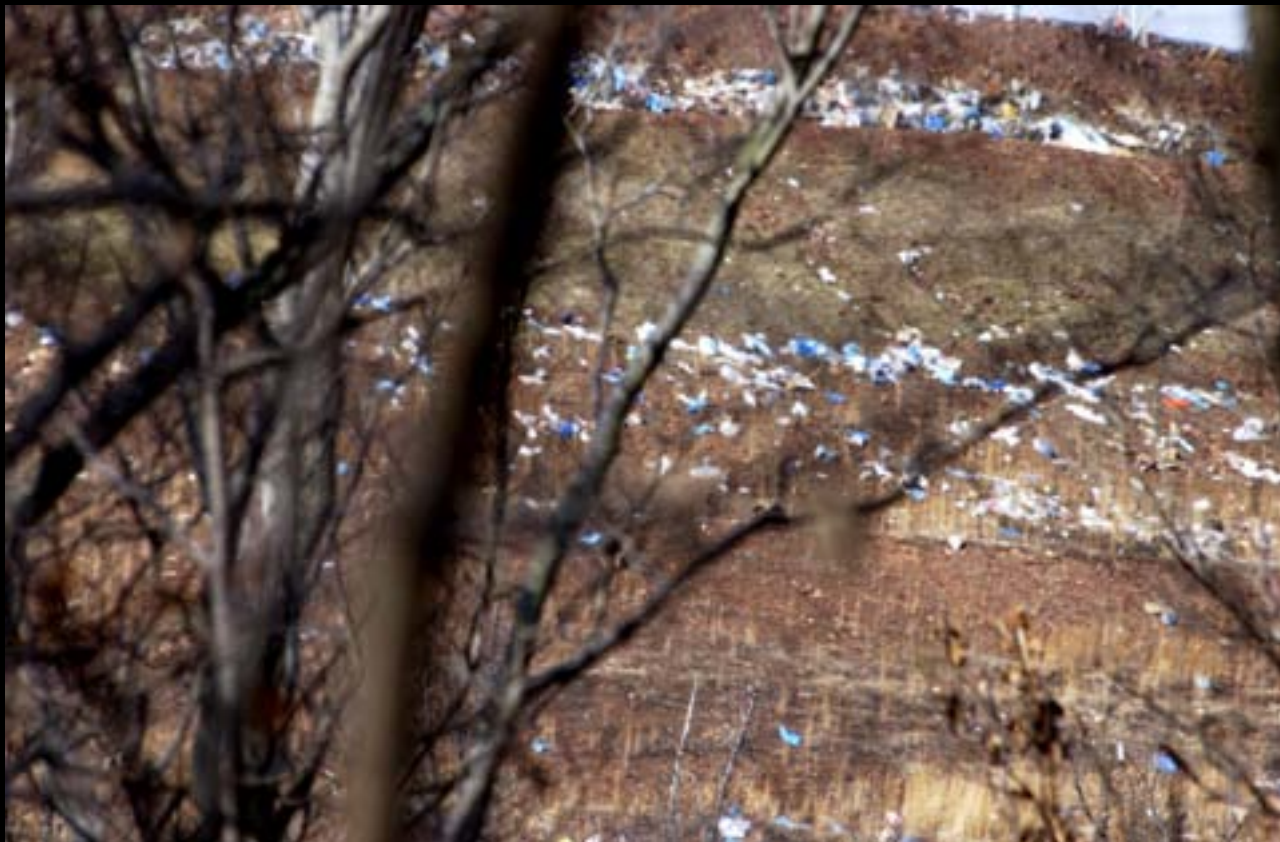
1-70

Approximately 500 ft of exposed trash on southside visible from neighboring homeowner's property. This area is considered finished and closed.

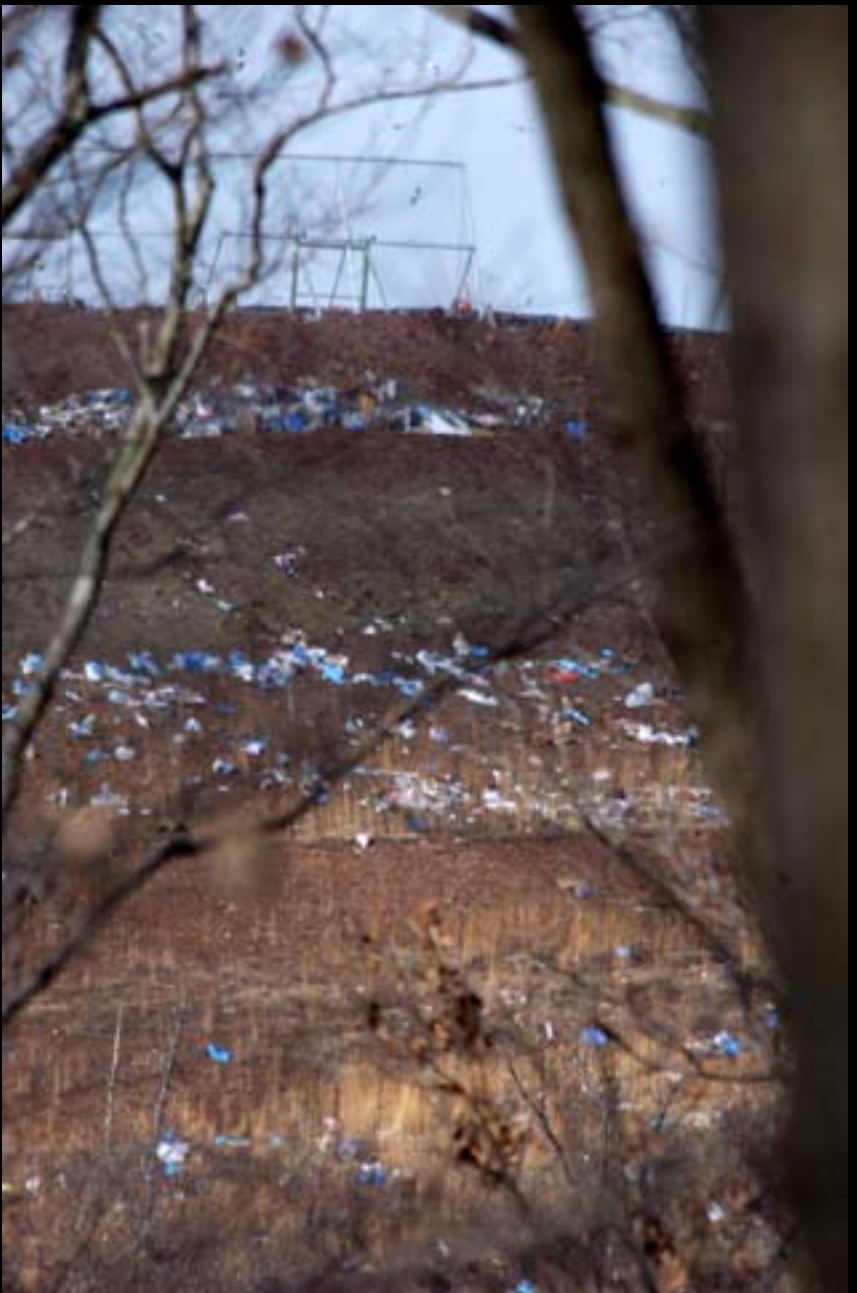
Southside supposedly finished area with exposed trash, wind-blown trash, blue recycle bags (do the people who bother to use them know this is where they wind up?) unstable banks, deep erosion.

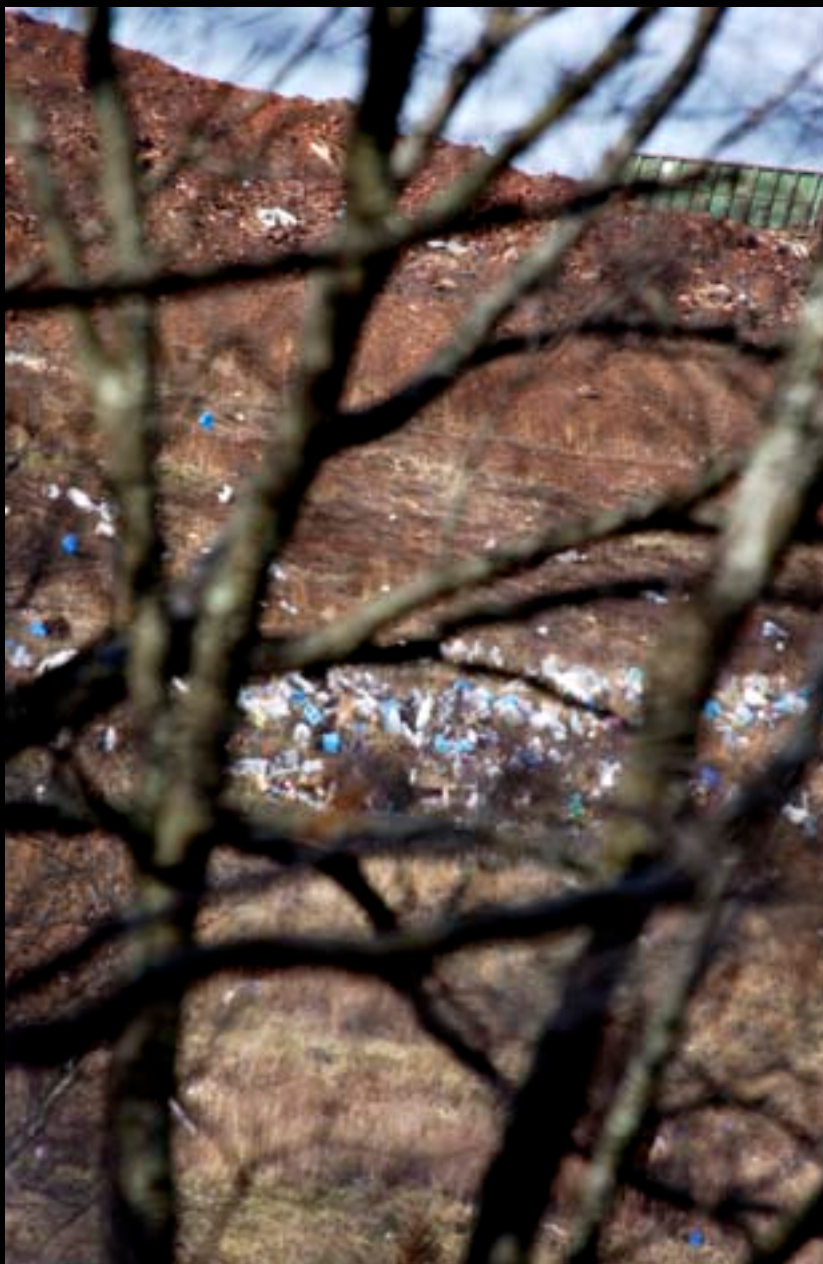
Southside view of same area as August 07 photos showed no cover in this same area, now on Jan 12, 08 still no slope cover and no stability. Exposed rocks.

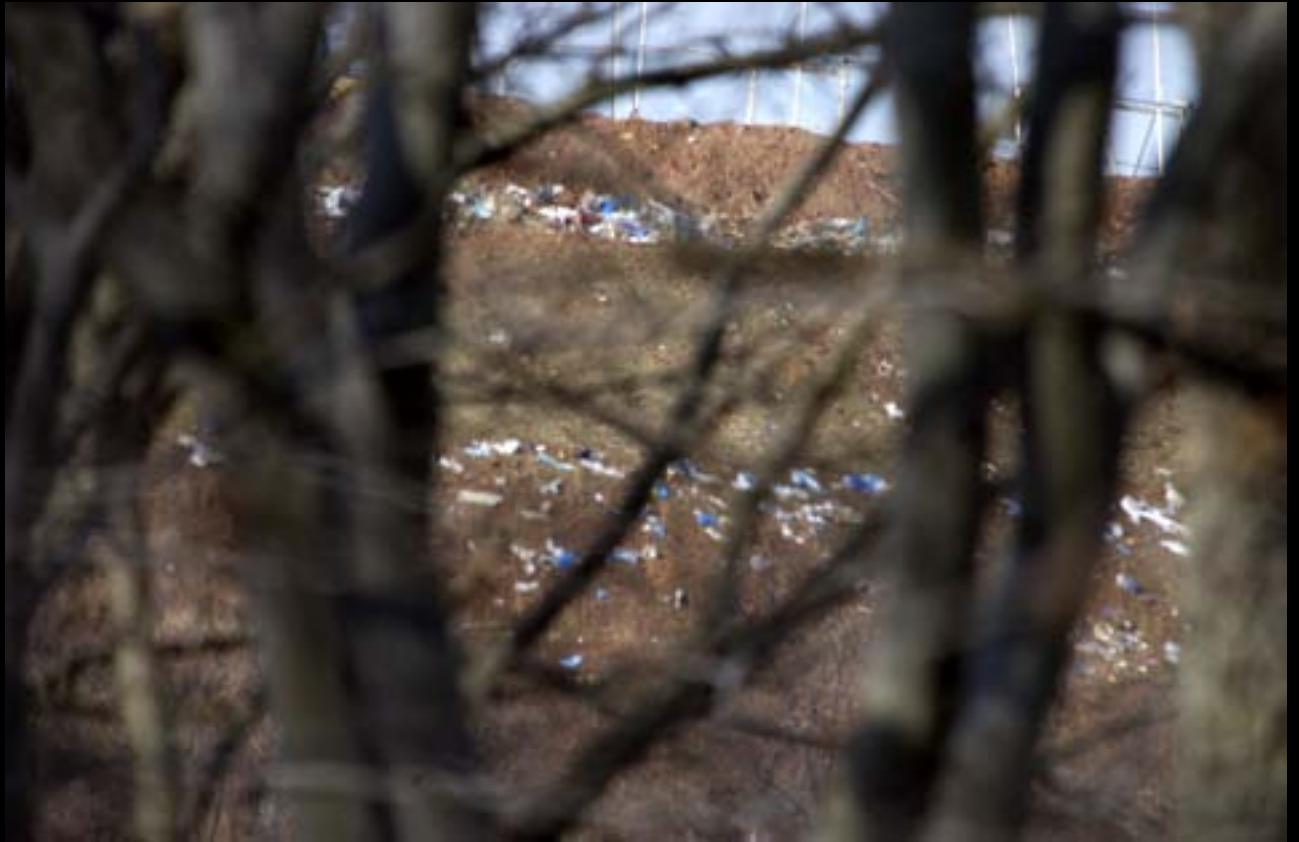
4-50

Southside view from homeowner's property. Large amount of exposed trash and windblown trash.

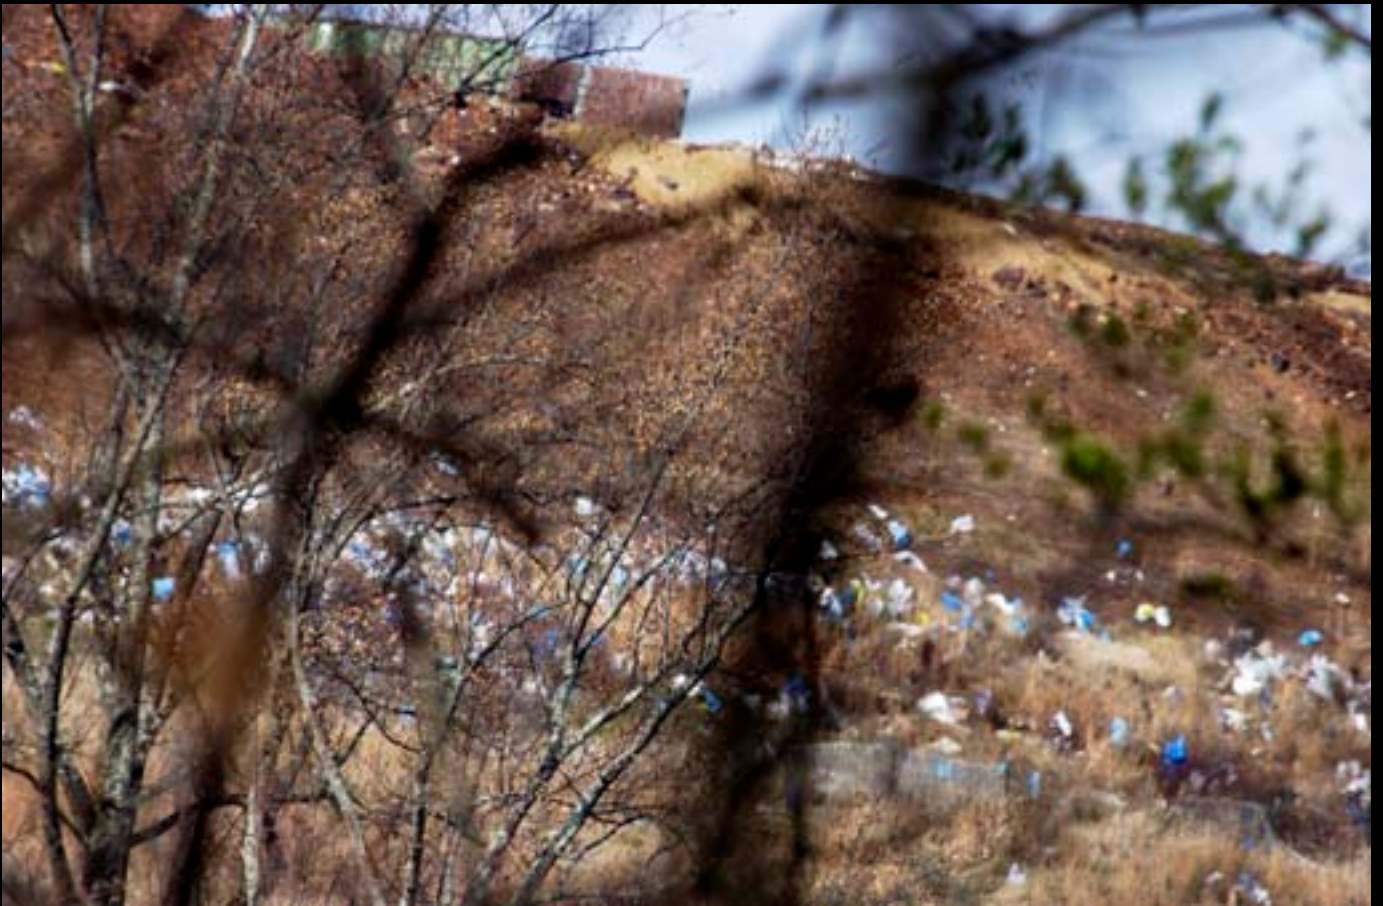
Southside lack of vegetation causing instability. All these slopes need to be redone correctly and re-seeded. Trash needs to be compacted and covered with 6 inches of dirt, intermediate cover should be 12 inches of dirt, and a layer of topsoil where seeds can grow.

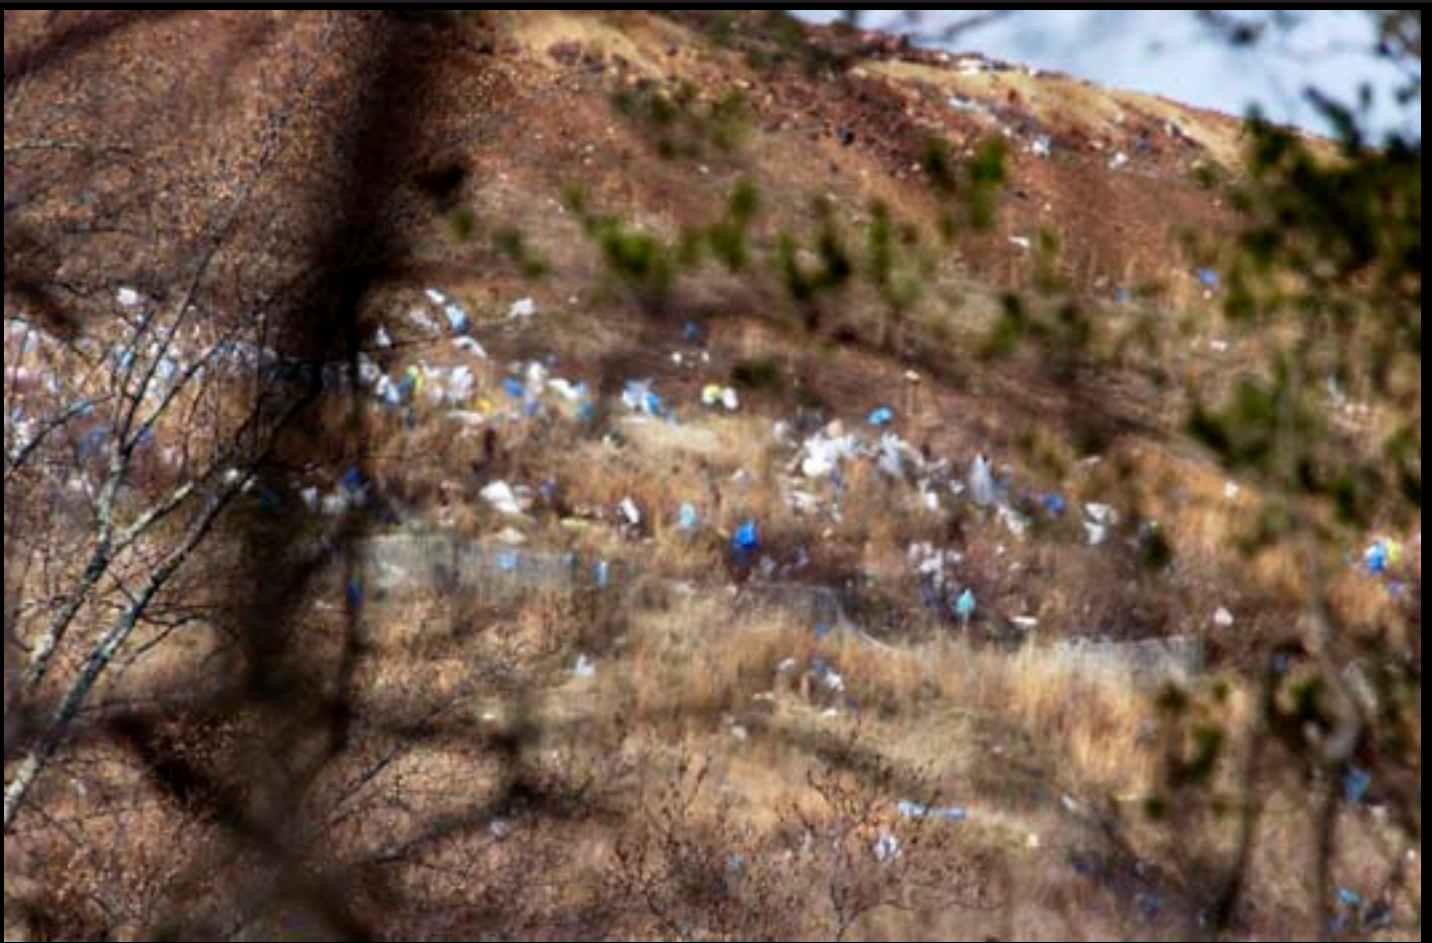
Southside. Steepness of slope. Areas without vegetation allow erosion causing gullies and instability. Uncovered, windblown trash. This is a completed cell, supposed to be finished, as good as it gets.

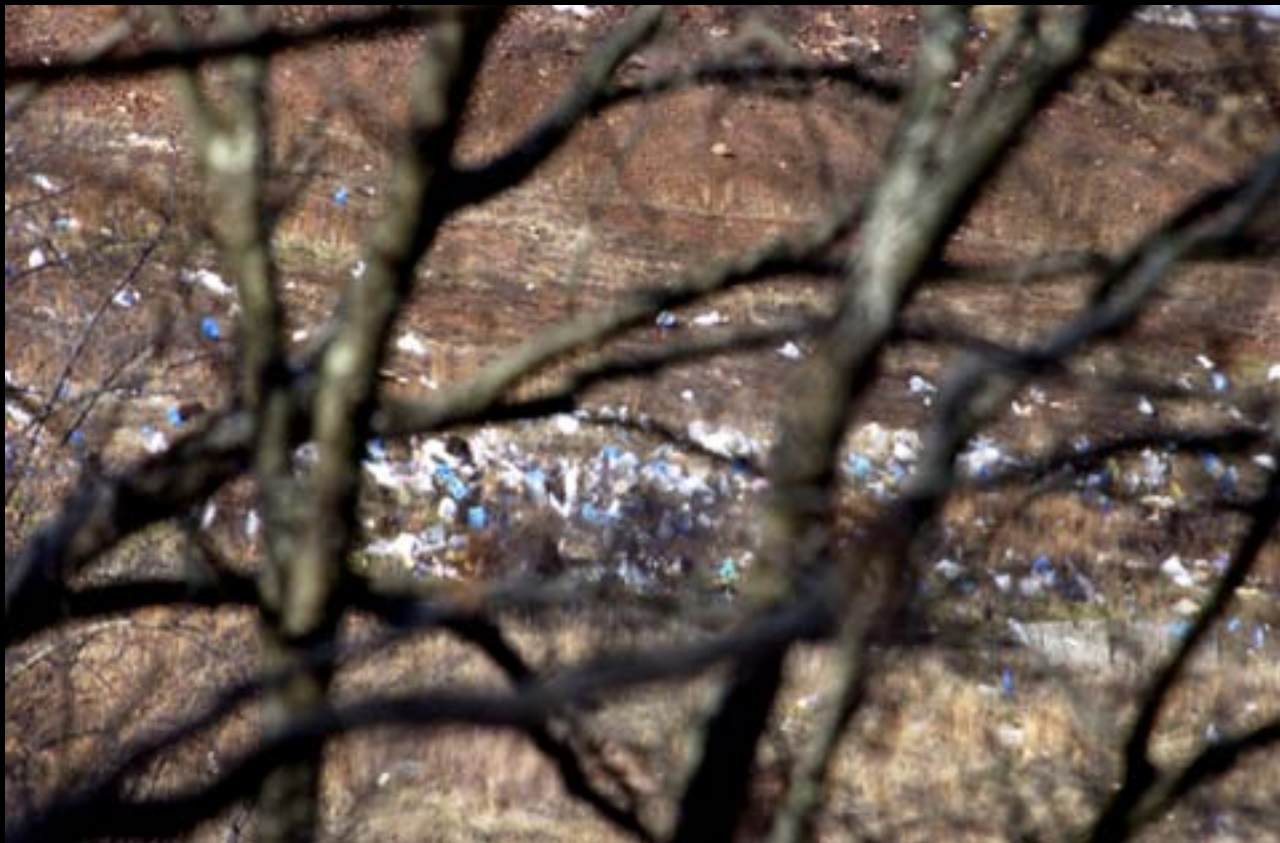
7-52

Southside exposed trash and ash below the apex of the fill area. Even ash is pushed over the edge.

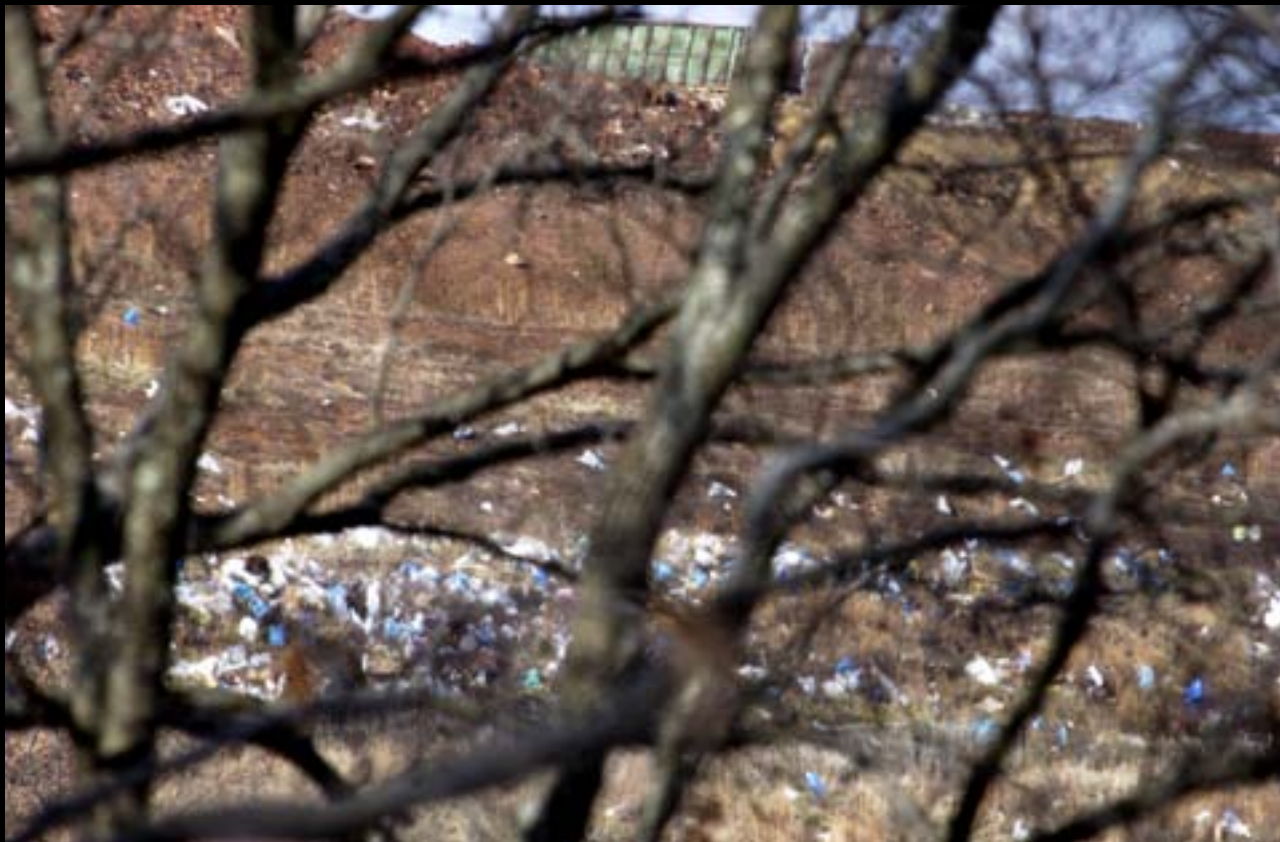
8-57

Southside under rolloff, trash pushed over slope, windblown and exposed trash.

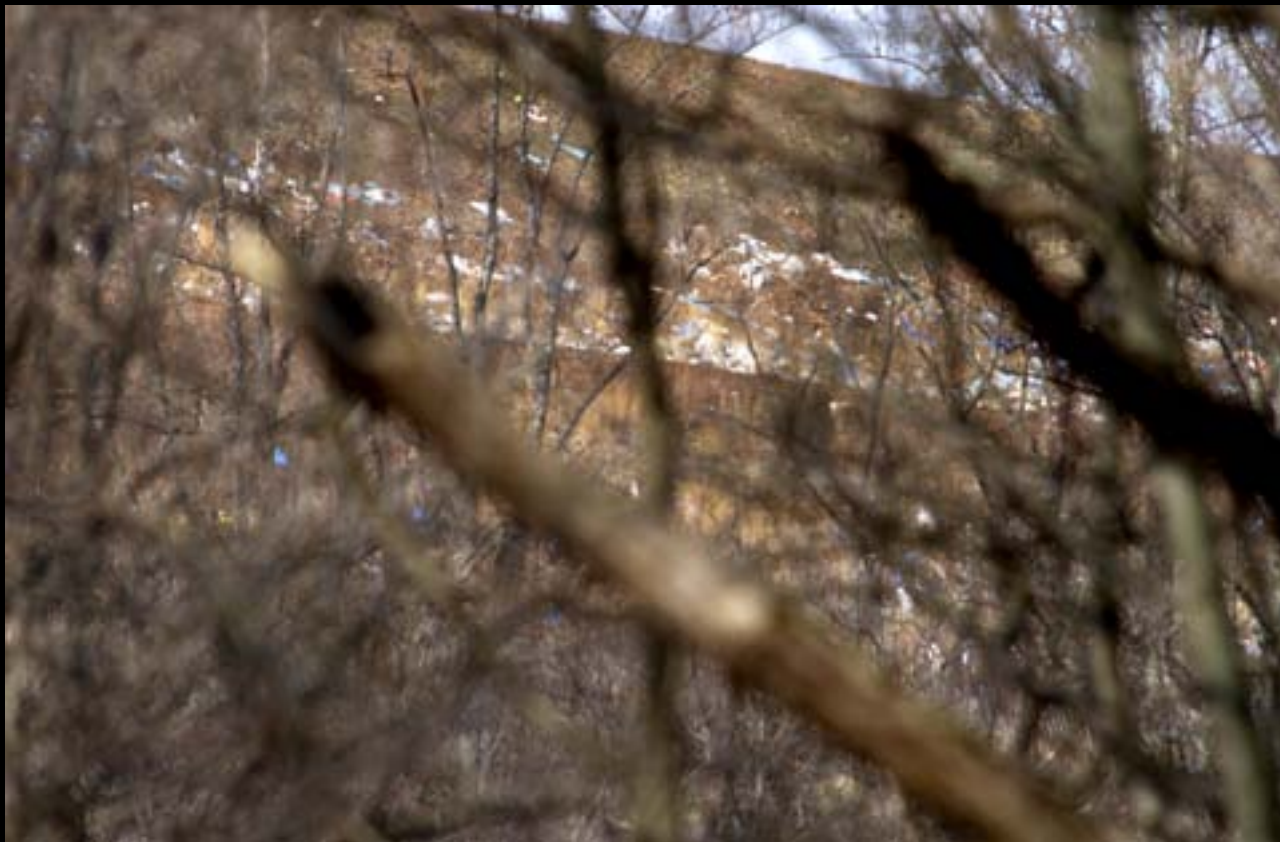
9-28

Southside bank is approximately 2:1 slope, very steep. Required to be 3:1 slope. Uncovered, exposed and windblown trash.

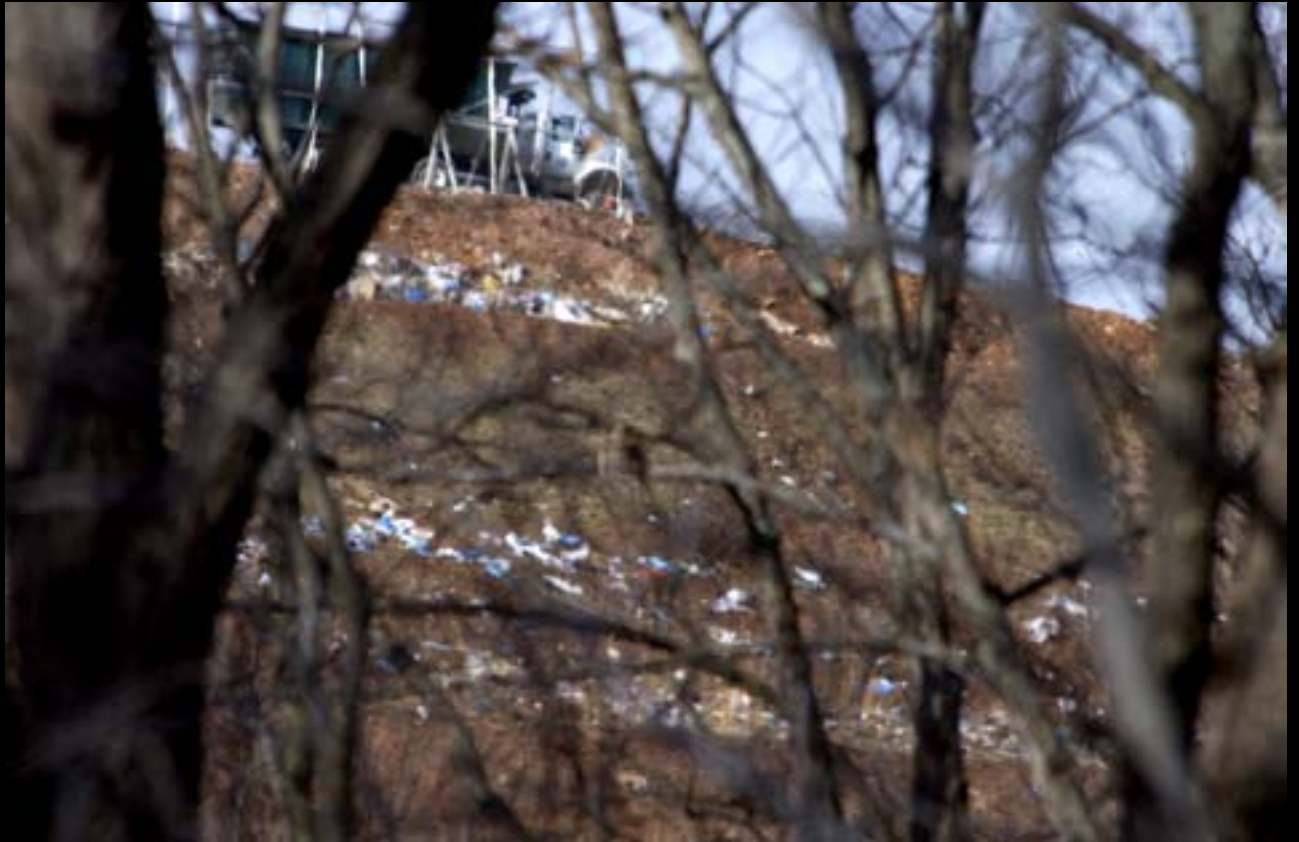
10-64

Southside trash truck leaving. Mass of exposed trash that was pushed over slope is size of truck.

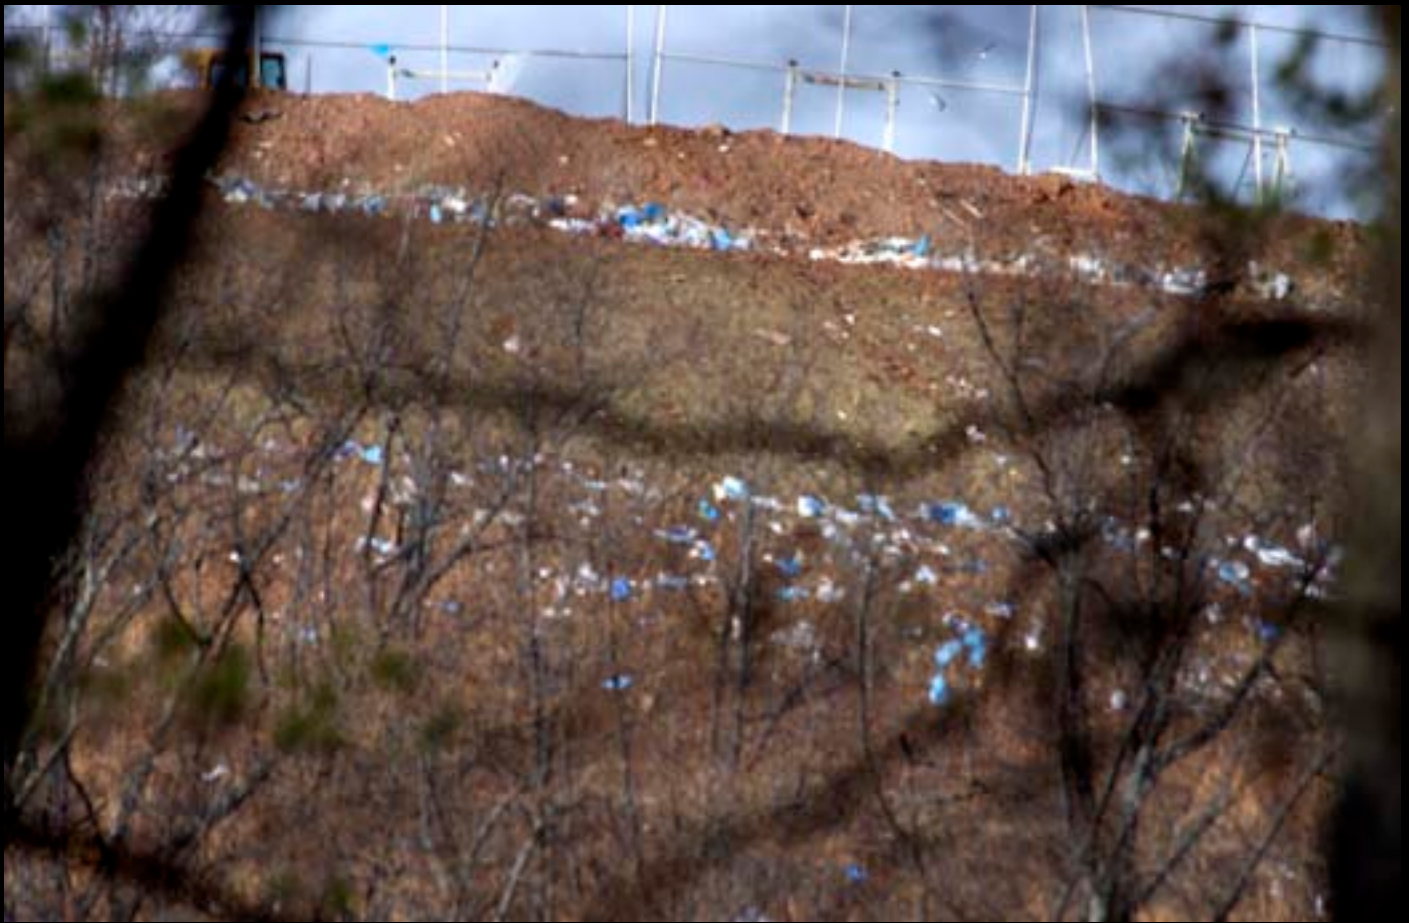
Southside slope not graded. Shows trash that was pushed over the slope where it can't be seen from homeowners dumping trash or MDE inspector that never bothers to look at the south side at all.

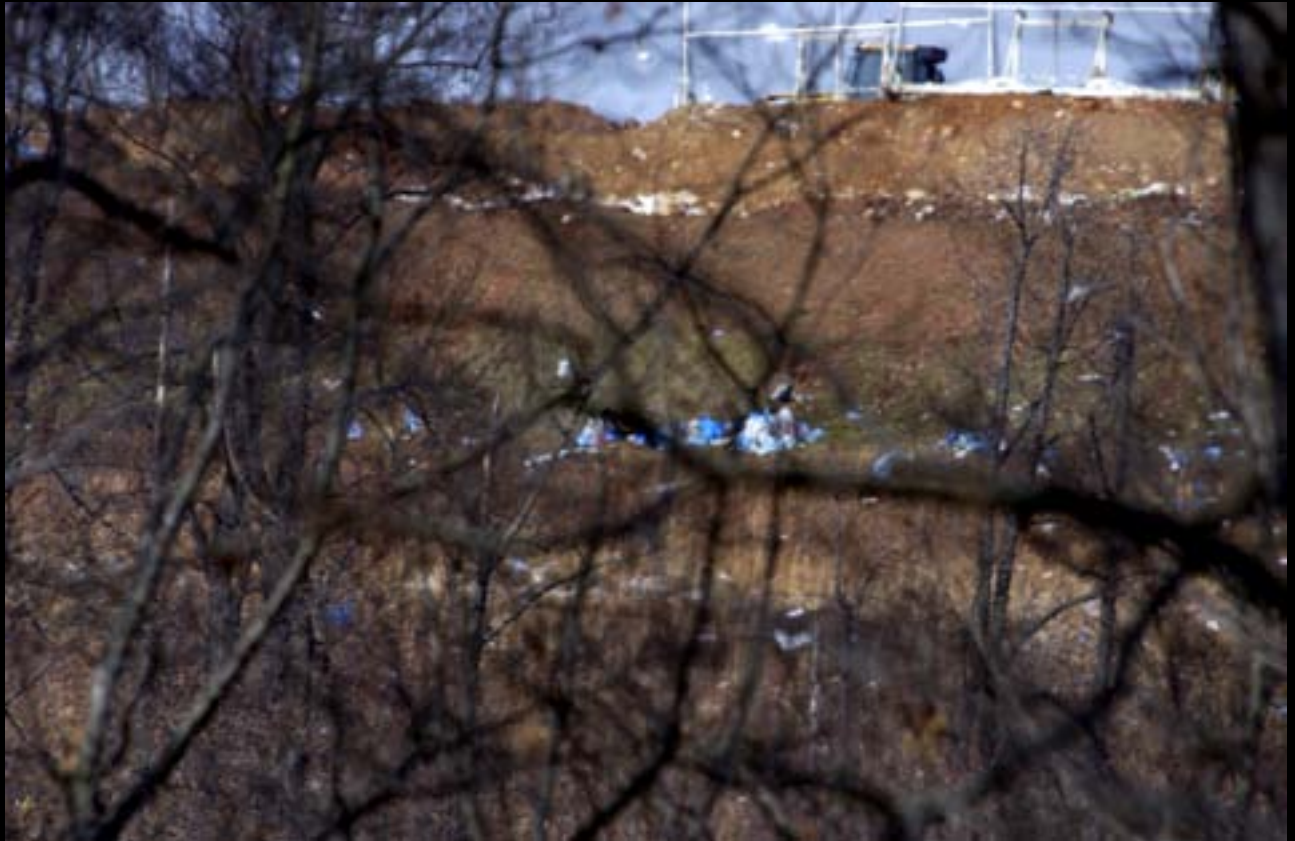
11-10

Southside slope large unstable area of uncovered trash with Harford Sanitation truck dumping at top.

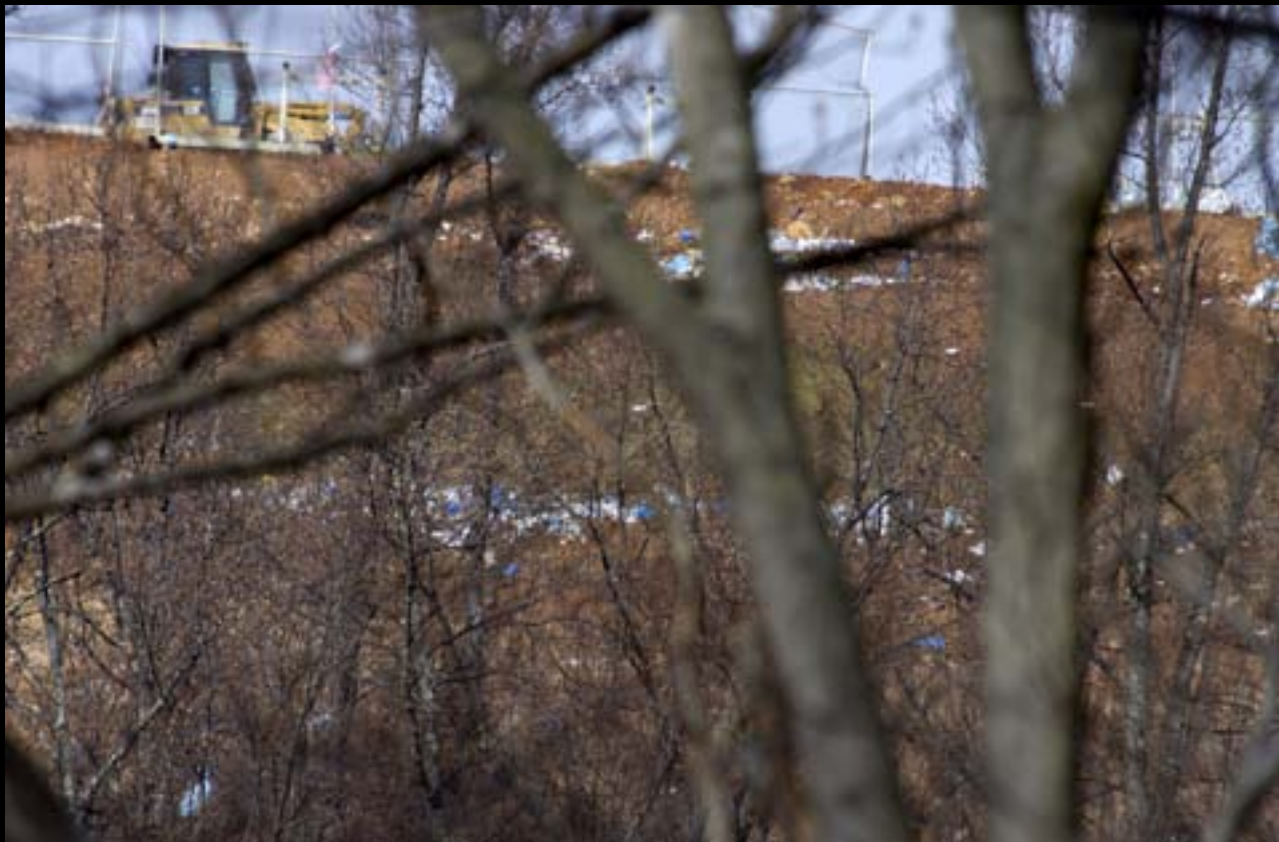
12-18

Southside view. Loader pushing trash, often pushing it over the edge. Uncovered trash, windblown trash, inadequate intermediate cover.

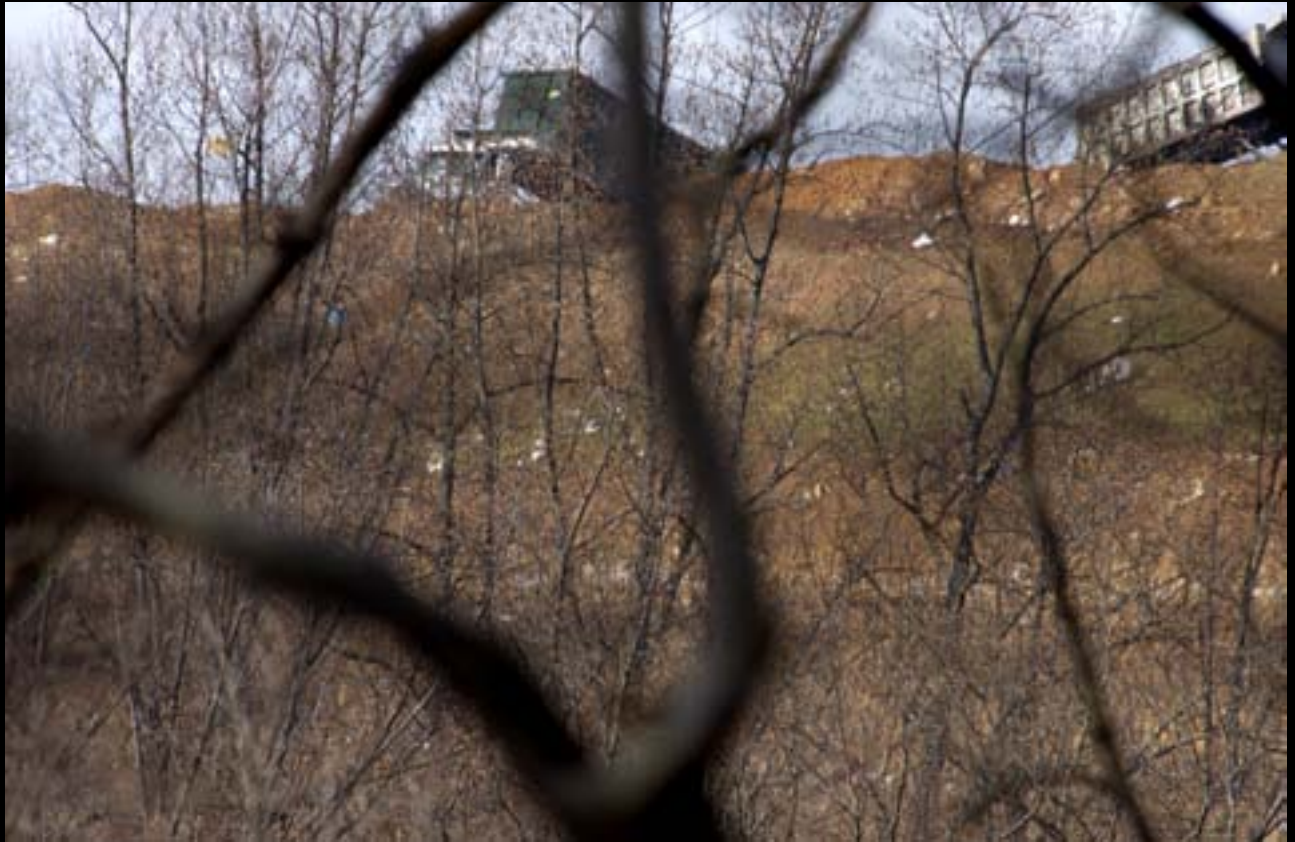
13-43

Ash truck and homeowner bin being dumped. Area under ash truck shows trash that was pushed over the edge. Southside.

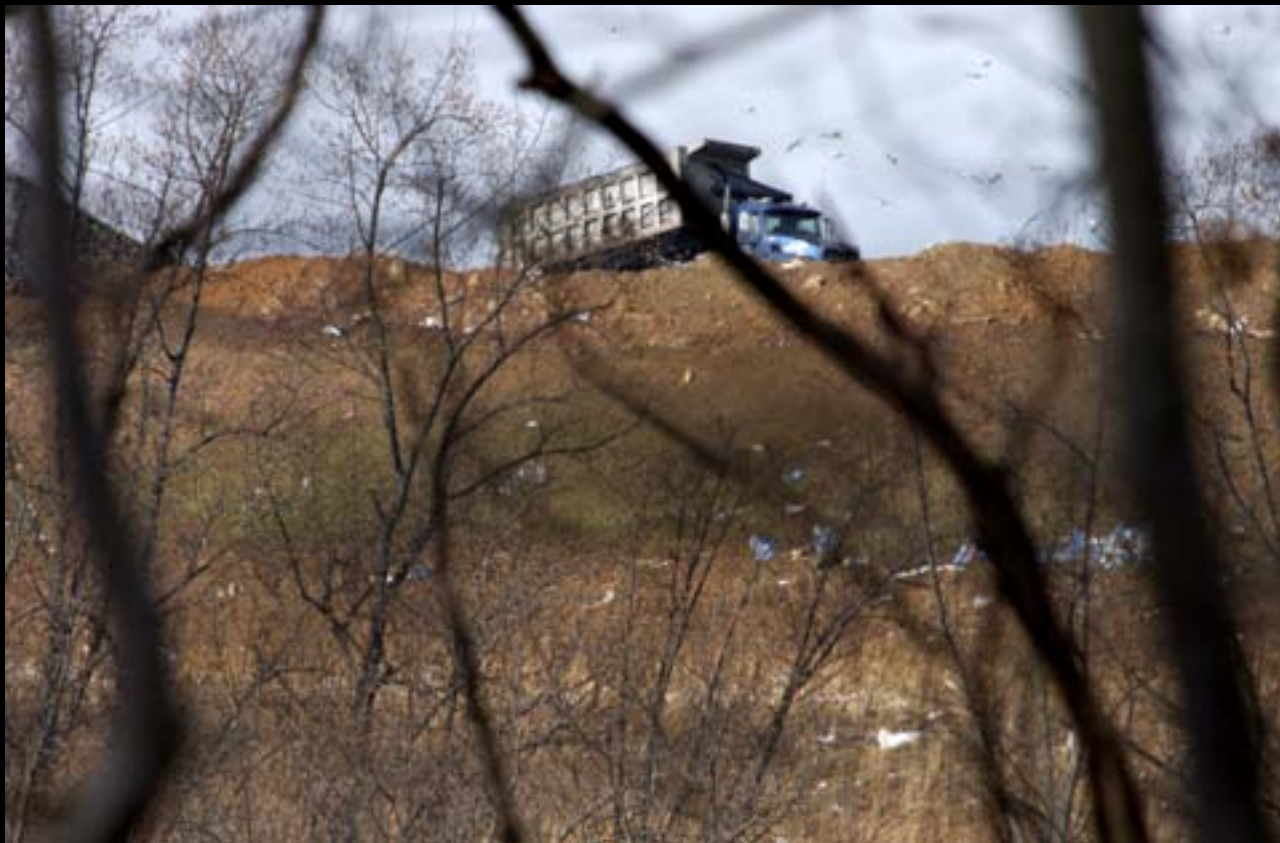
14-44

Ash truck, unstable bank, windblown trash. Southside.

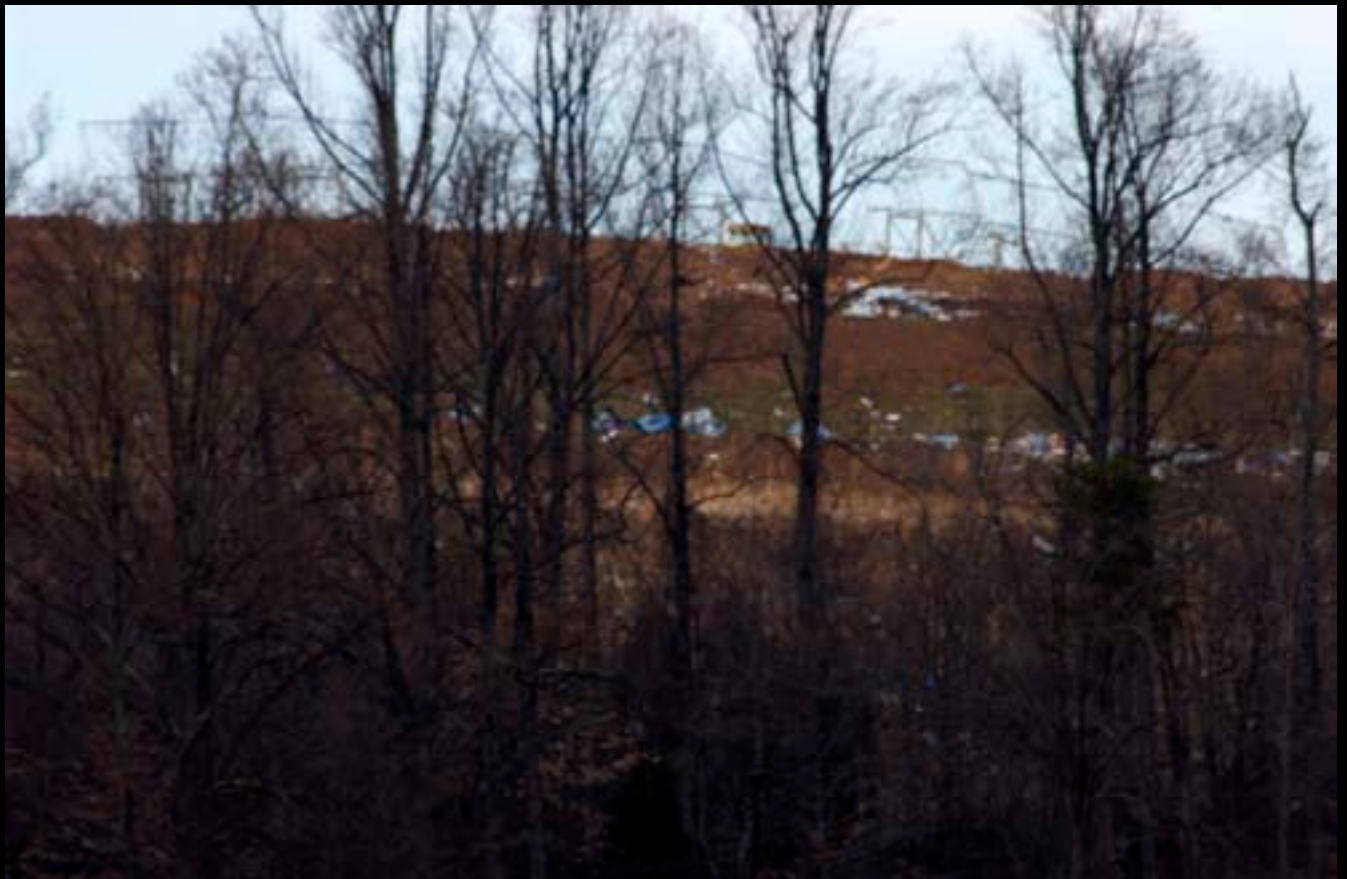
Southside view of exposed trash is visible from Sandy Hook Rd., i.e. people can see it driving by in their cars. This should be some sight when the southern expansion puts this right over Deer Creek and the trash gets windblown into the creek.

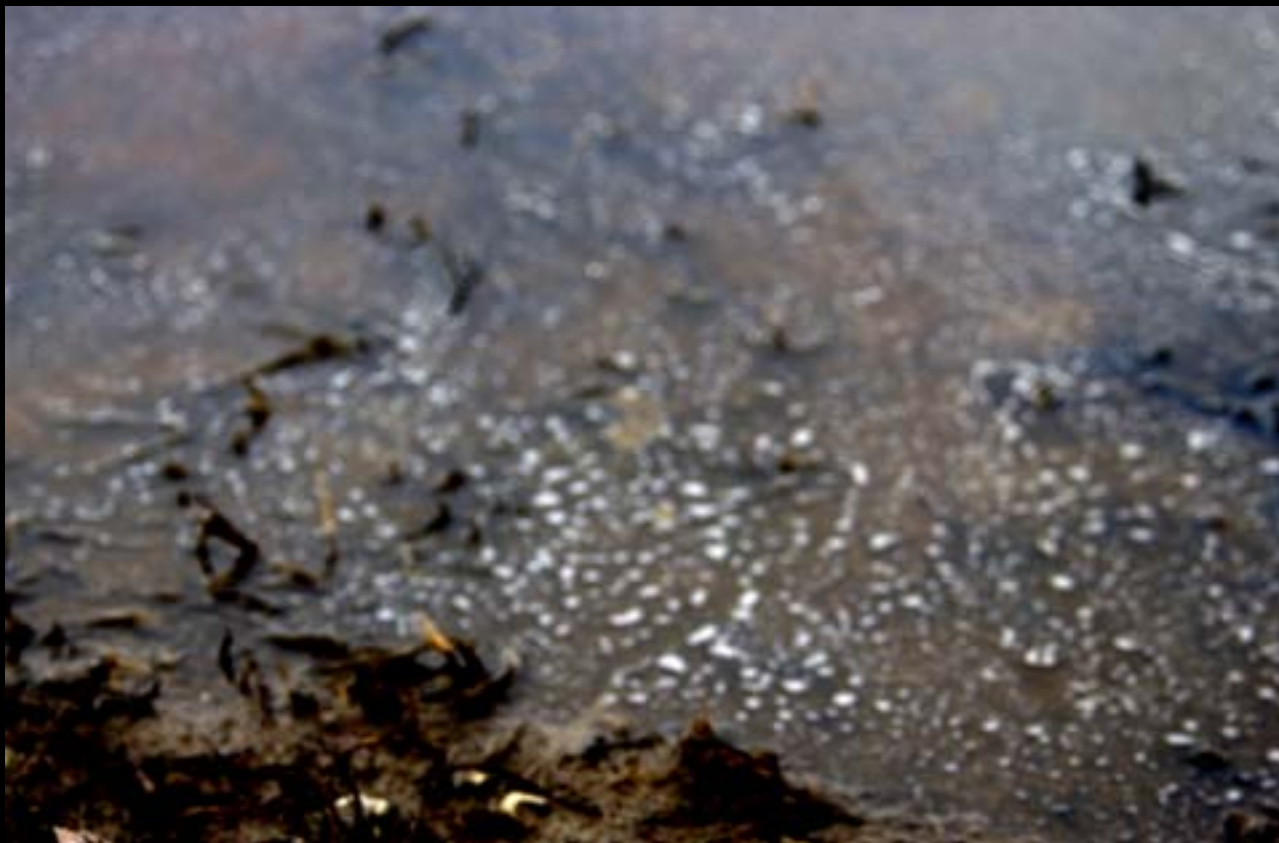
16-99

Closeup of puddle in equestrian trail near road. Oily substance quickly emerges. Oily substance has been in these puddles since trail was built.

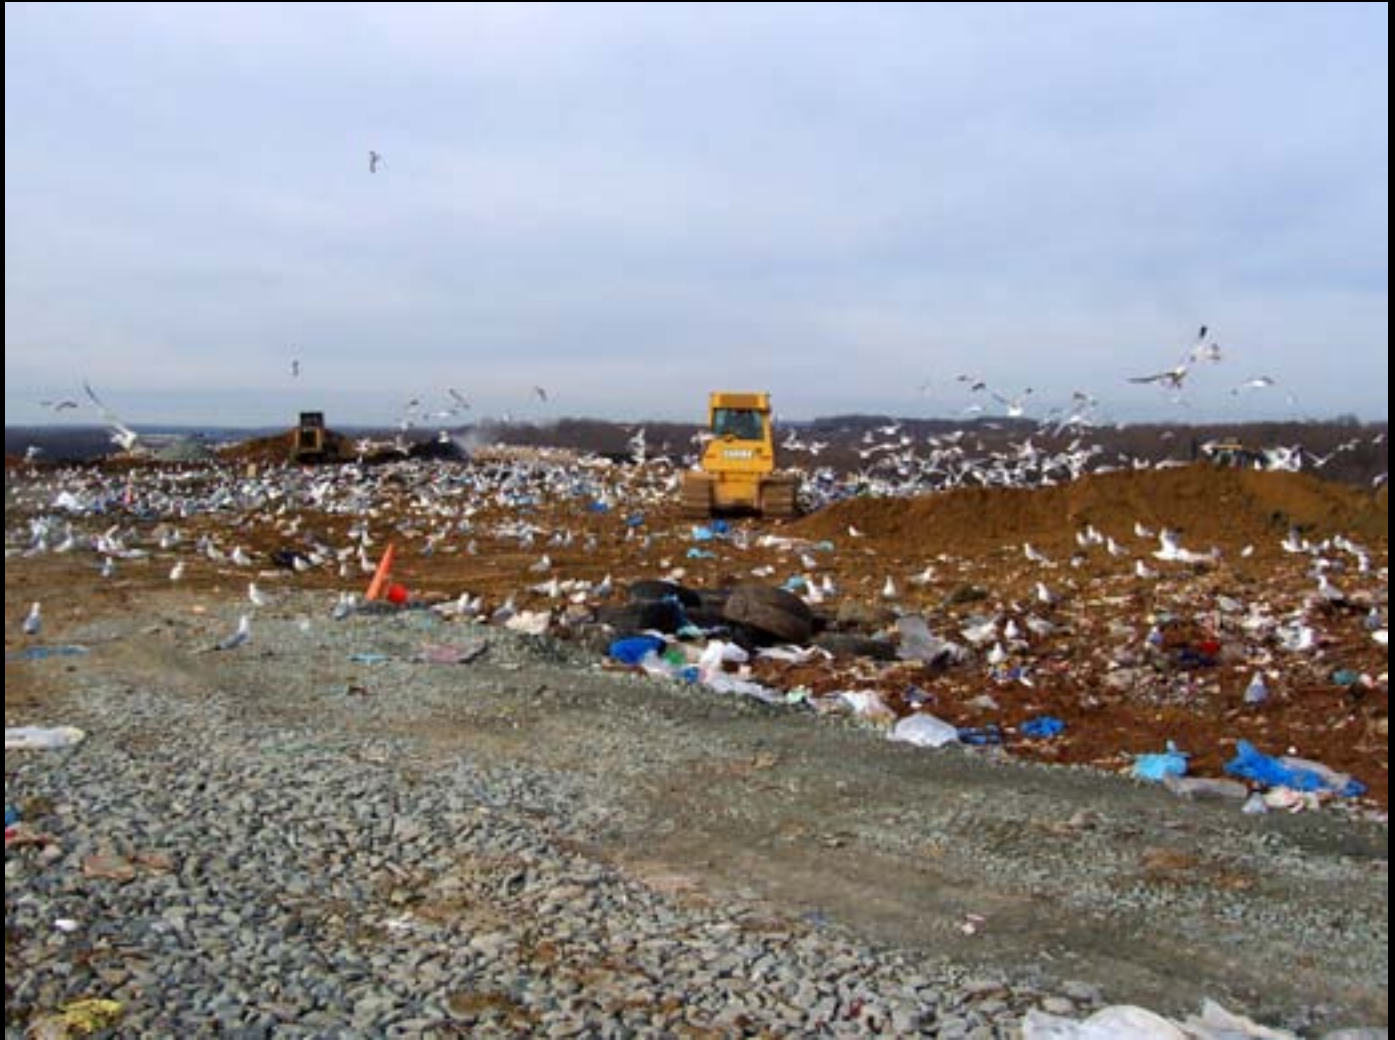
Landfill & Southside Jan 10 2008 003 Active working face at distance - large numbers of vectors (literally thousands)

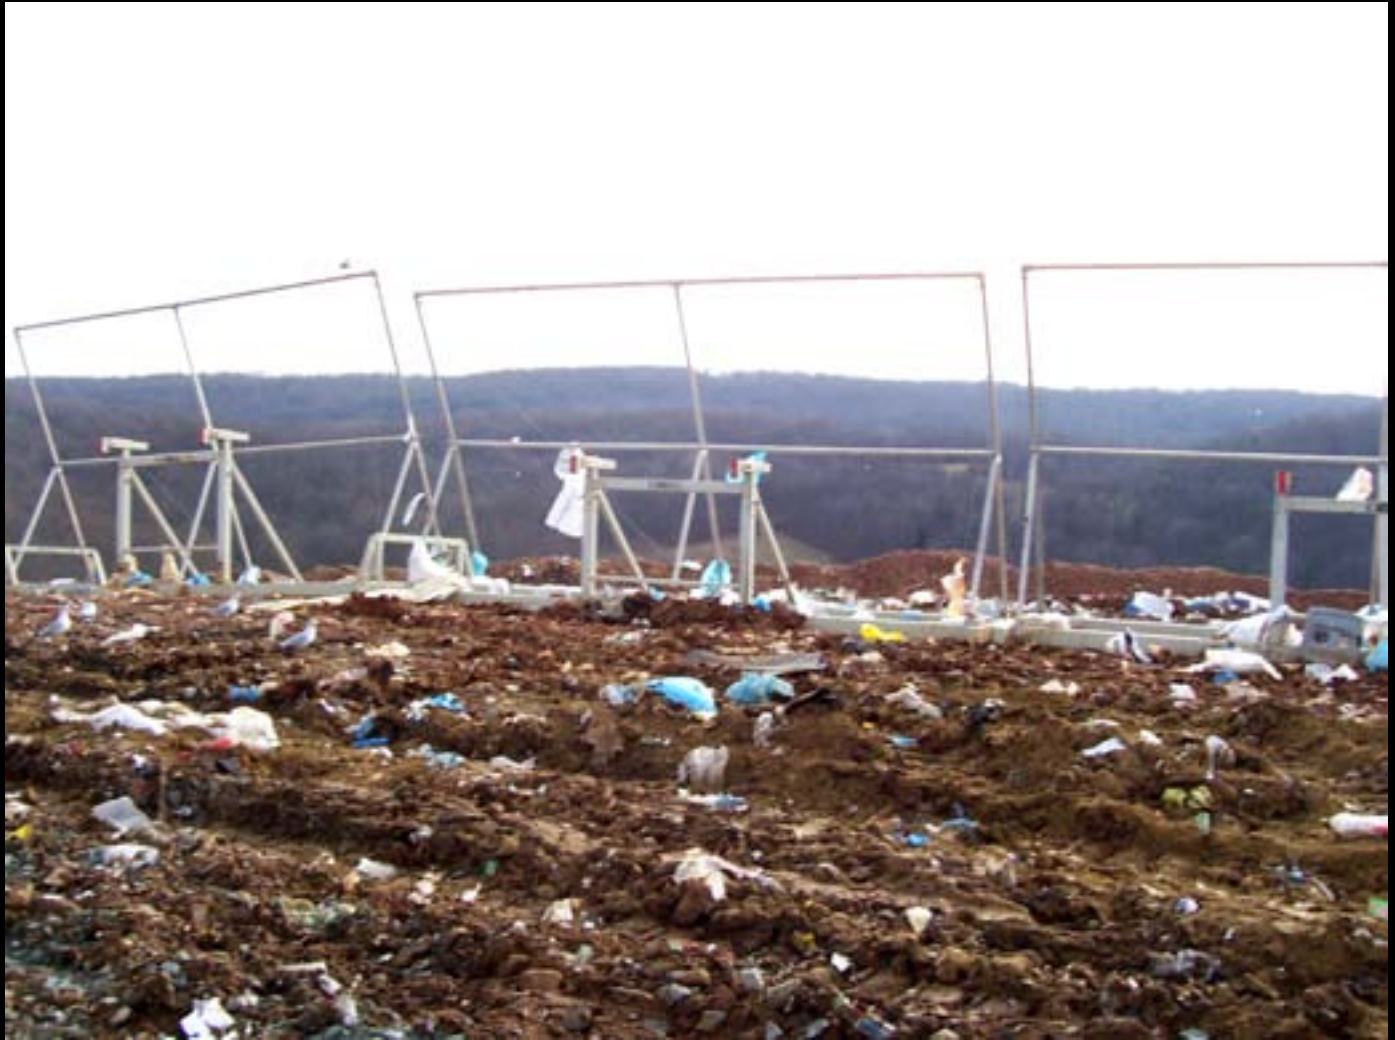
Landfill & Southside Jan 10 2008 004-1. Inactive working face - no 6' of cover.
