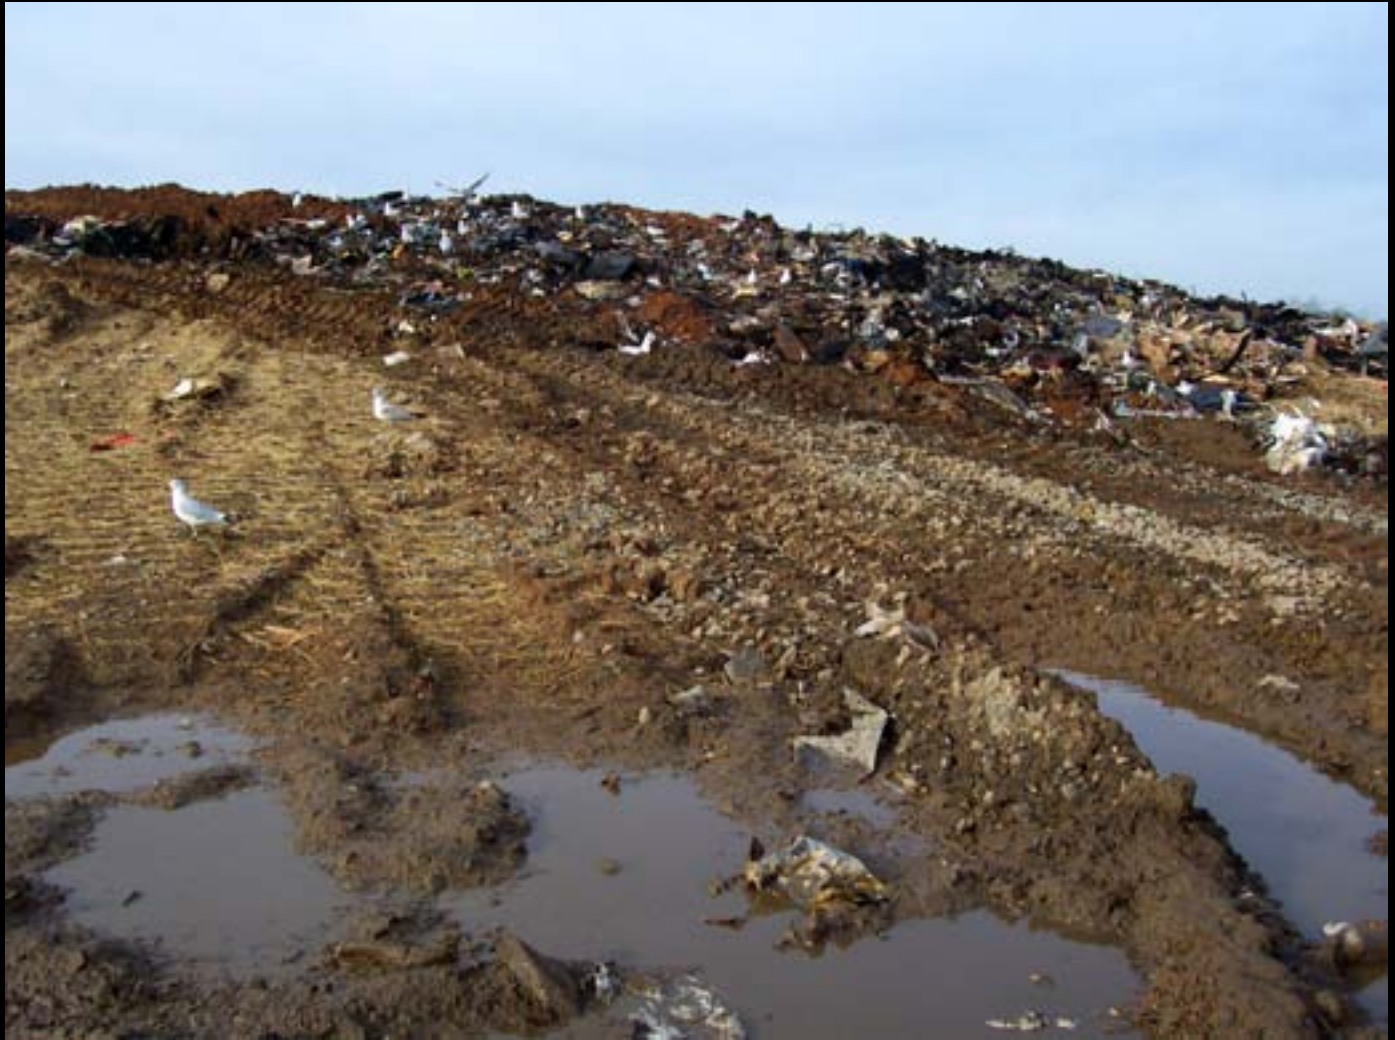
Landfill & Southside Jan 10 2008 006. Ponding water, inadequate daily cover

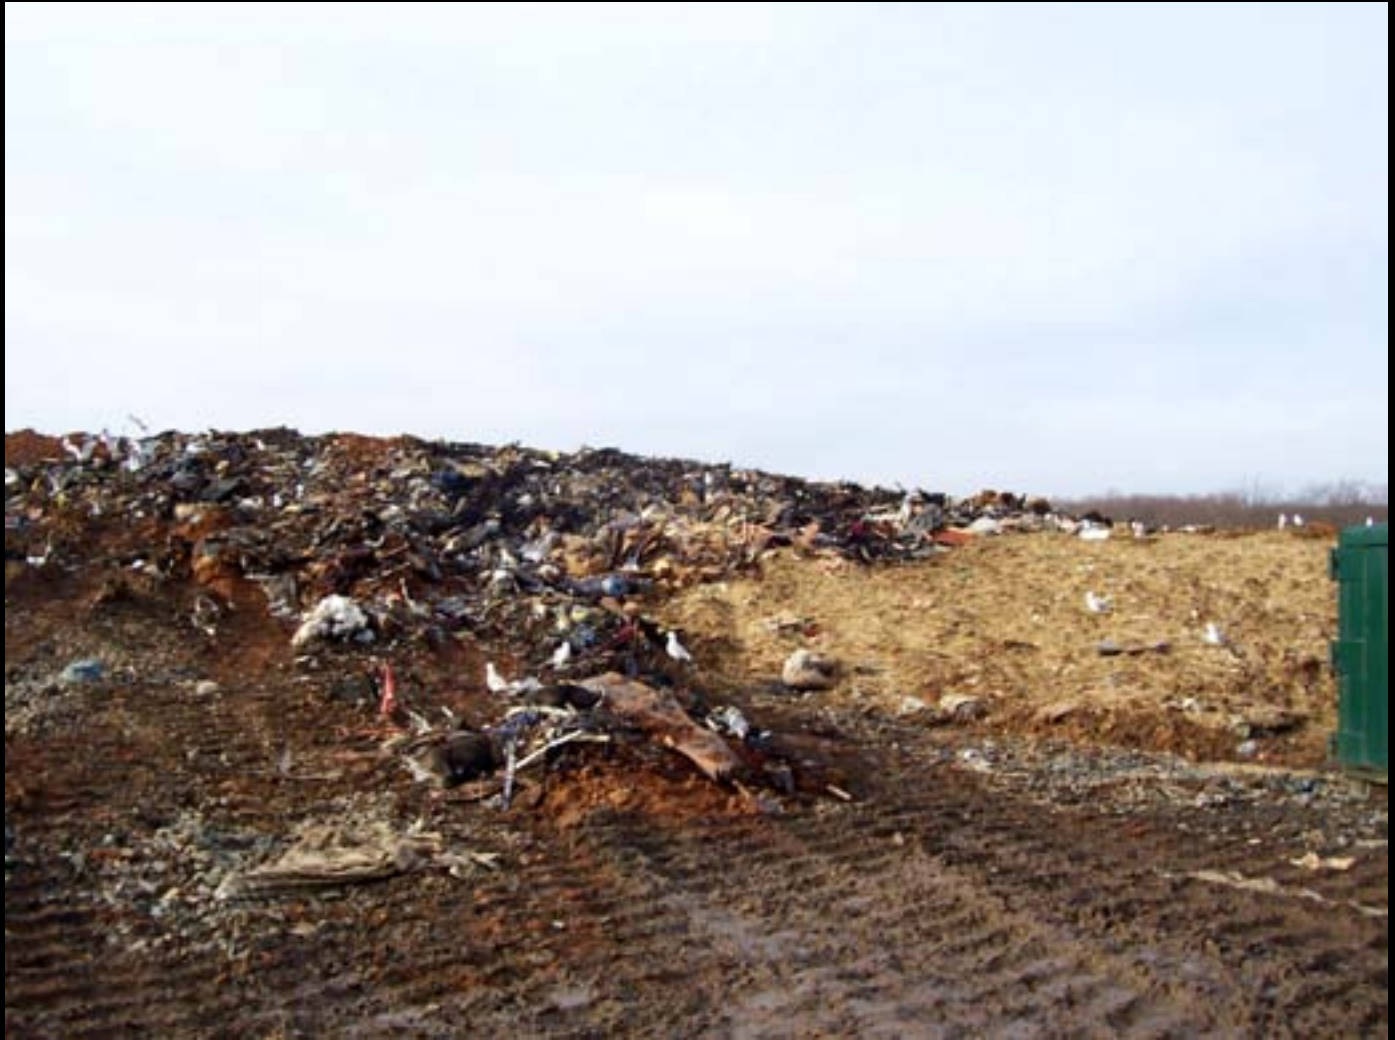
Landfill & Southside Jan 10 2008 008 Inadequate daily cover. Straw area already seeded over uncovered trash.

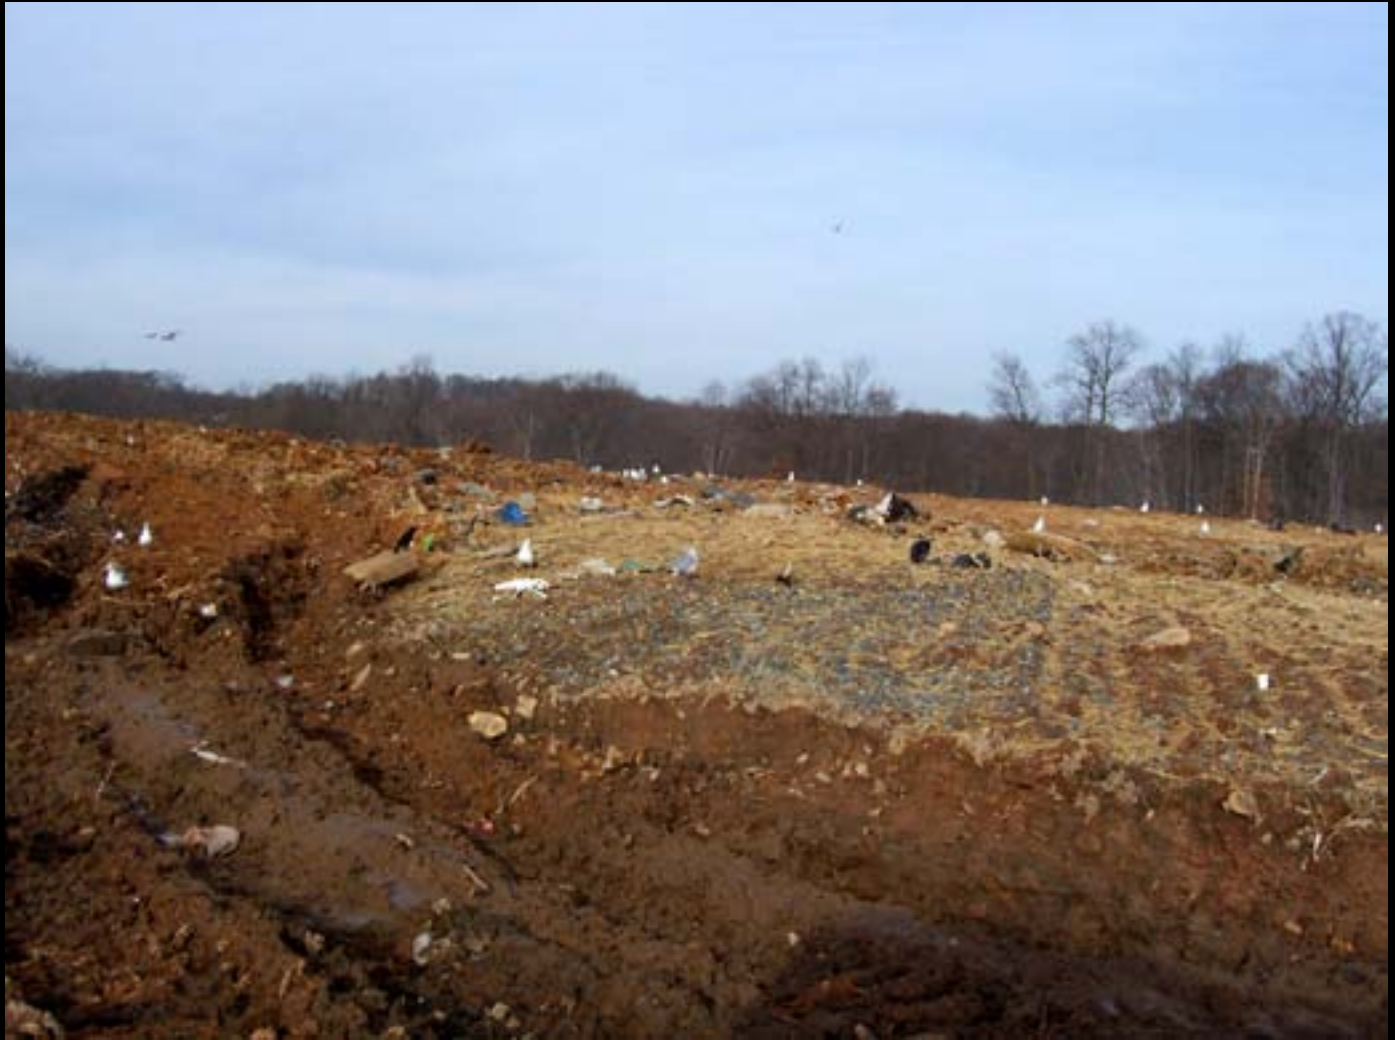
Landfill & Southside Jan 10 2008 009. Straw over seeded area no intermediate cover (1 foot)

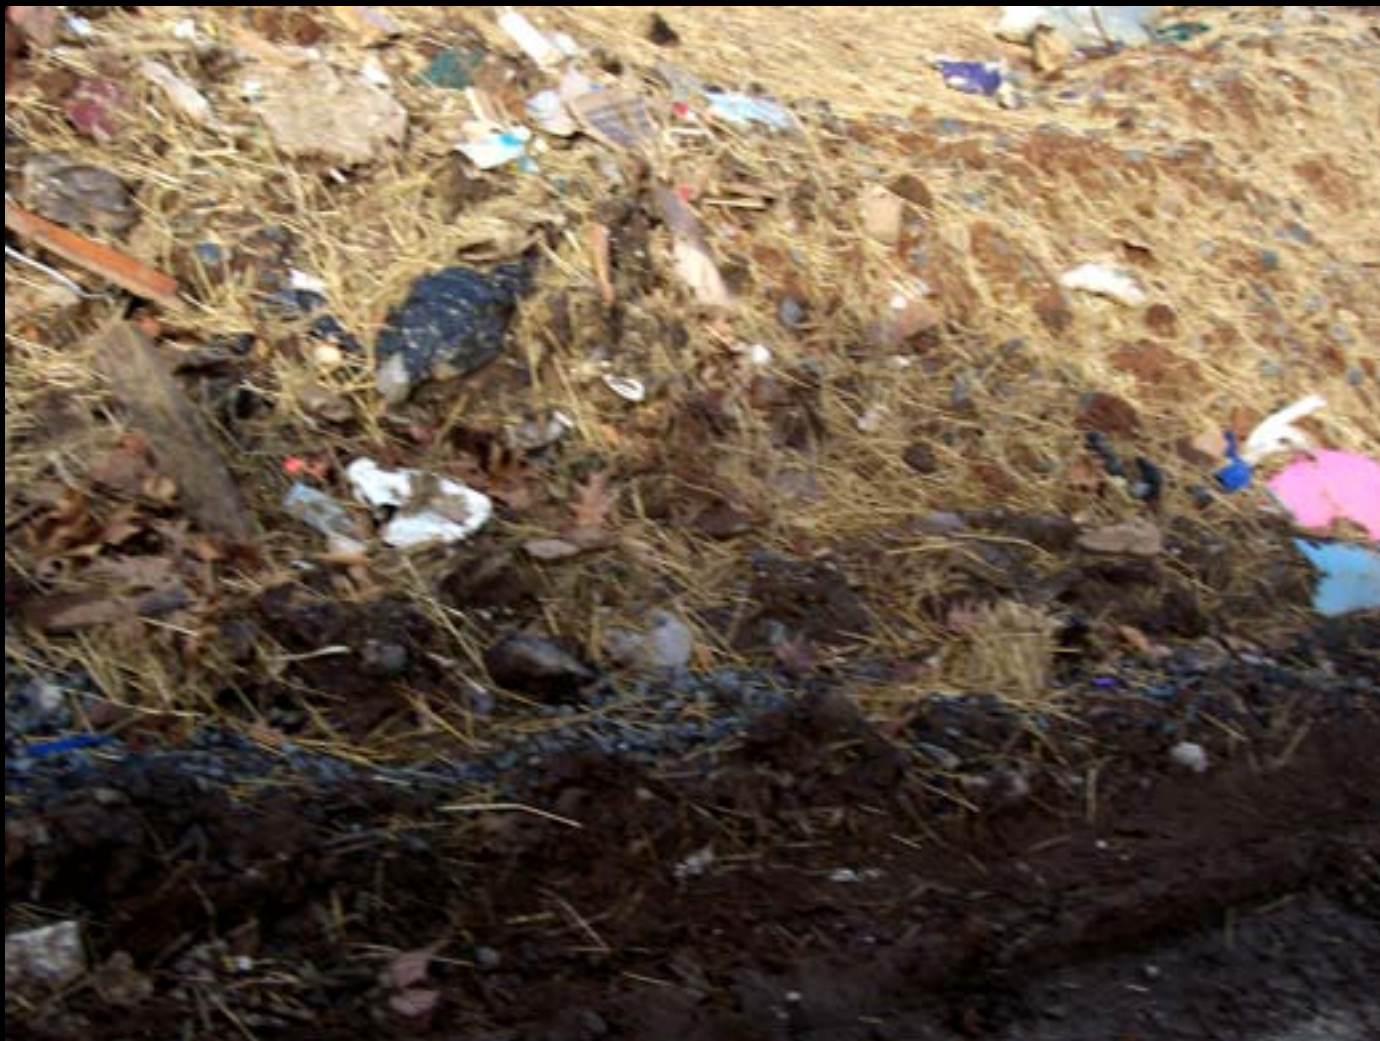
Landfill & Southside Jan 10 2008 010. Seeded over exposed garbage - inadequate intermediate cover (should be 1 foot)

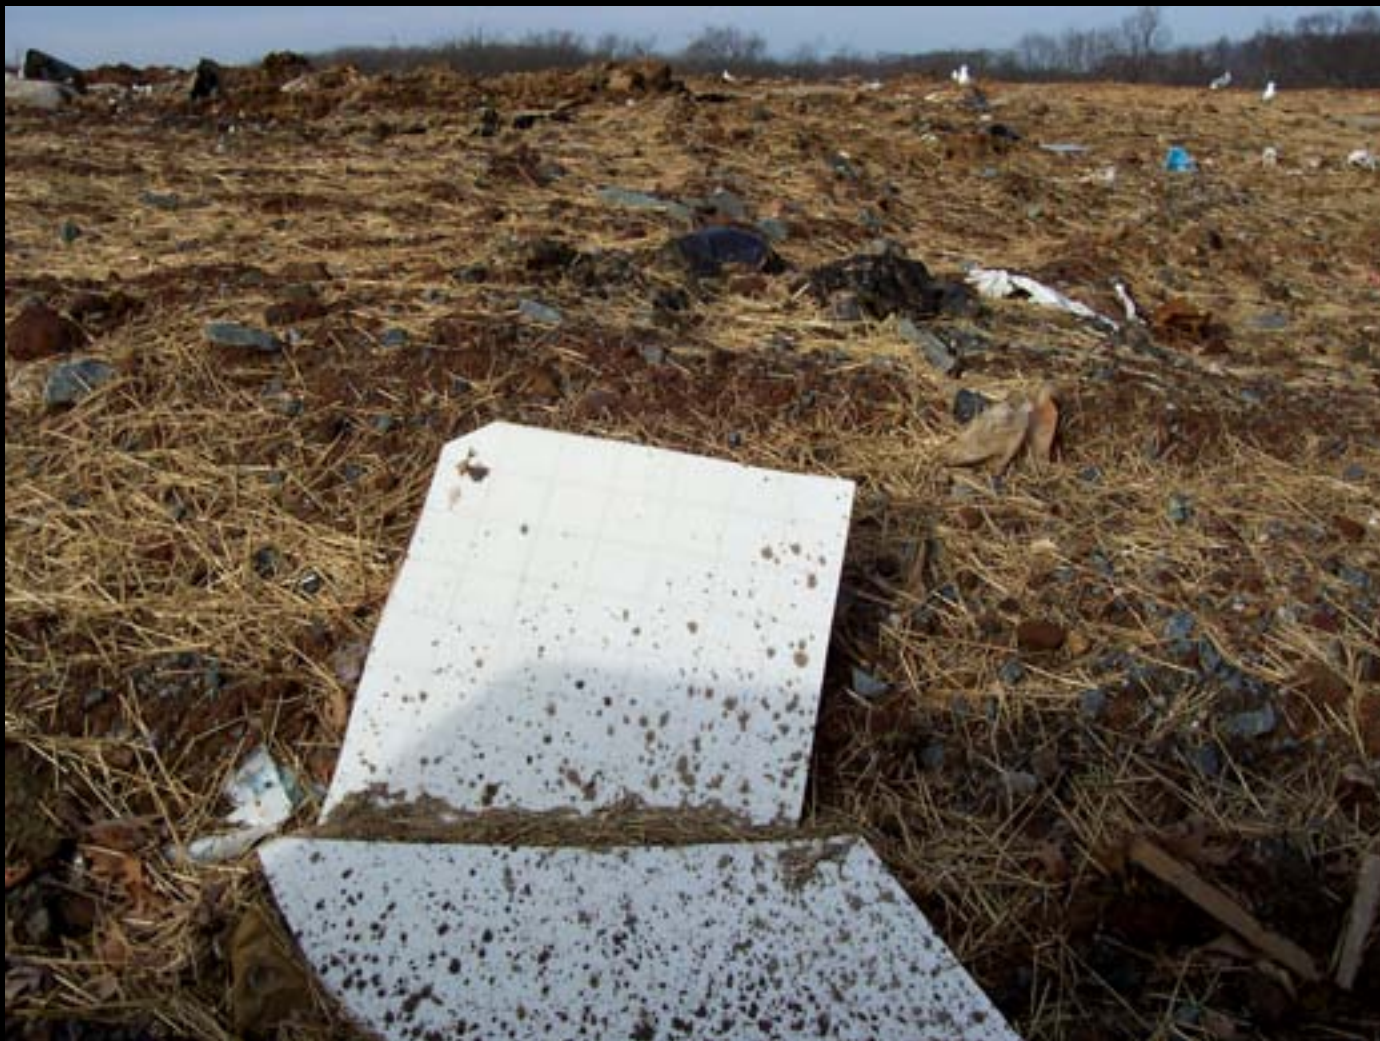
Landfill & Southside Jan 10 2008 013. Seeded over exposed garbage - inadequate cover - attracts vectors.

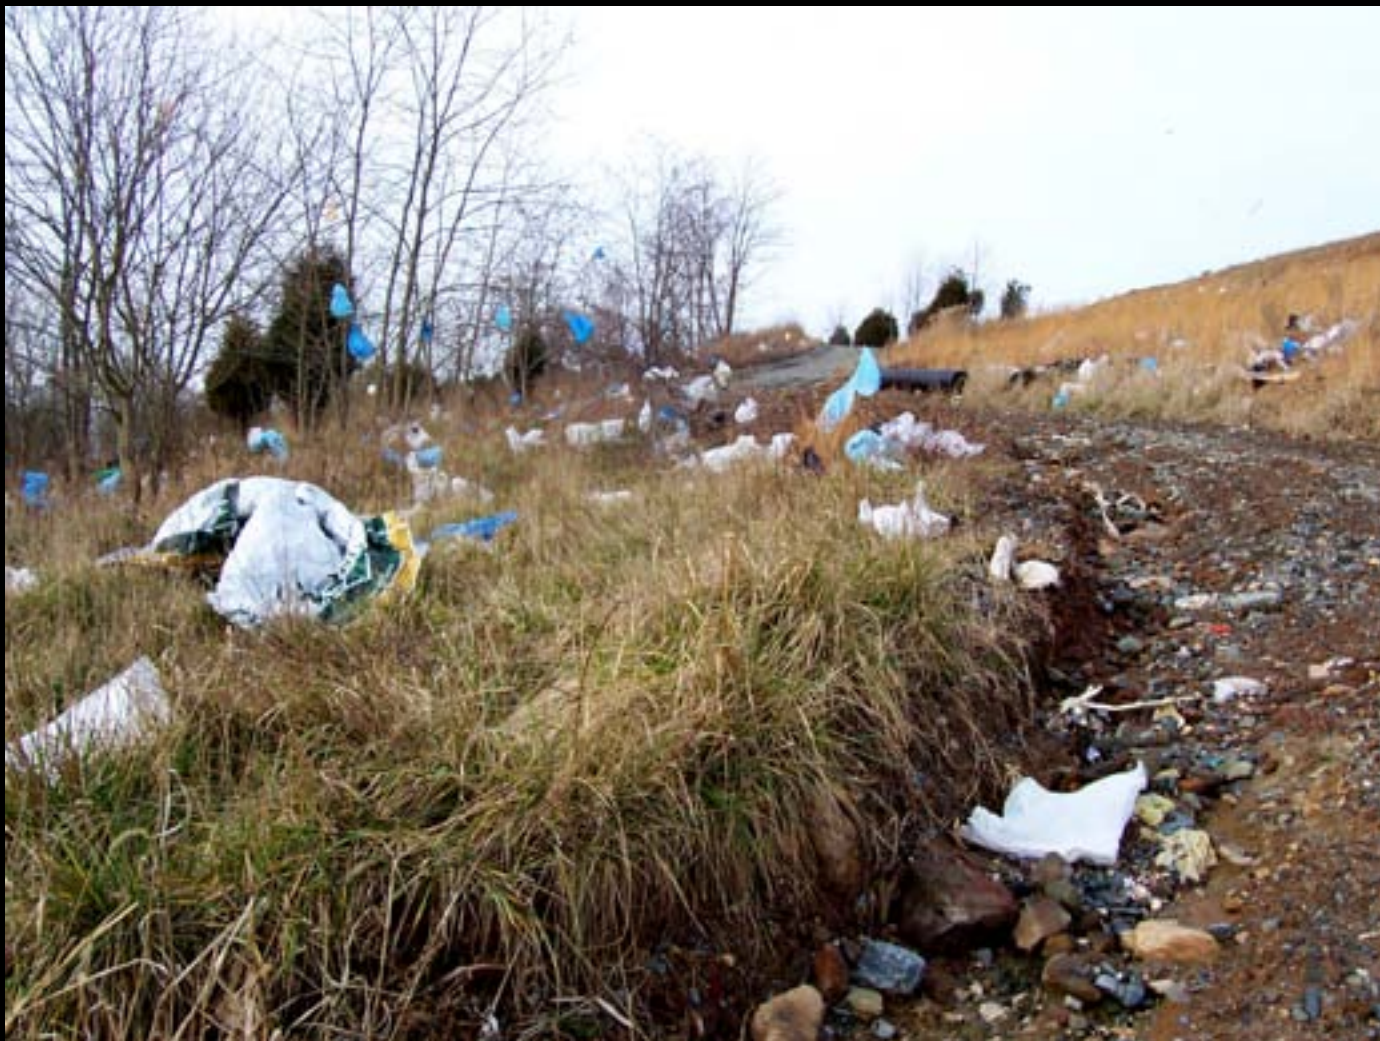
Landfill & Southside Jan 10 2008 015. Southside - exposed garbage, leachate and windblown trash.

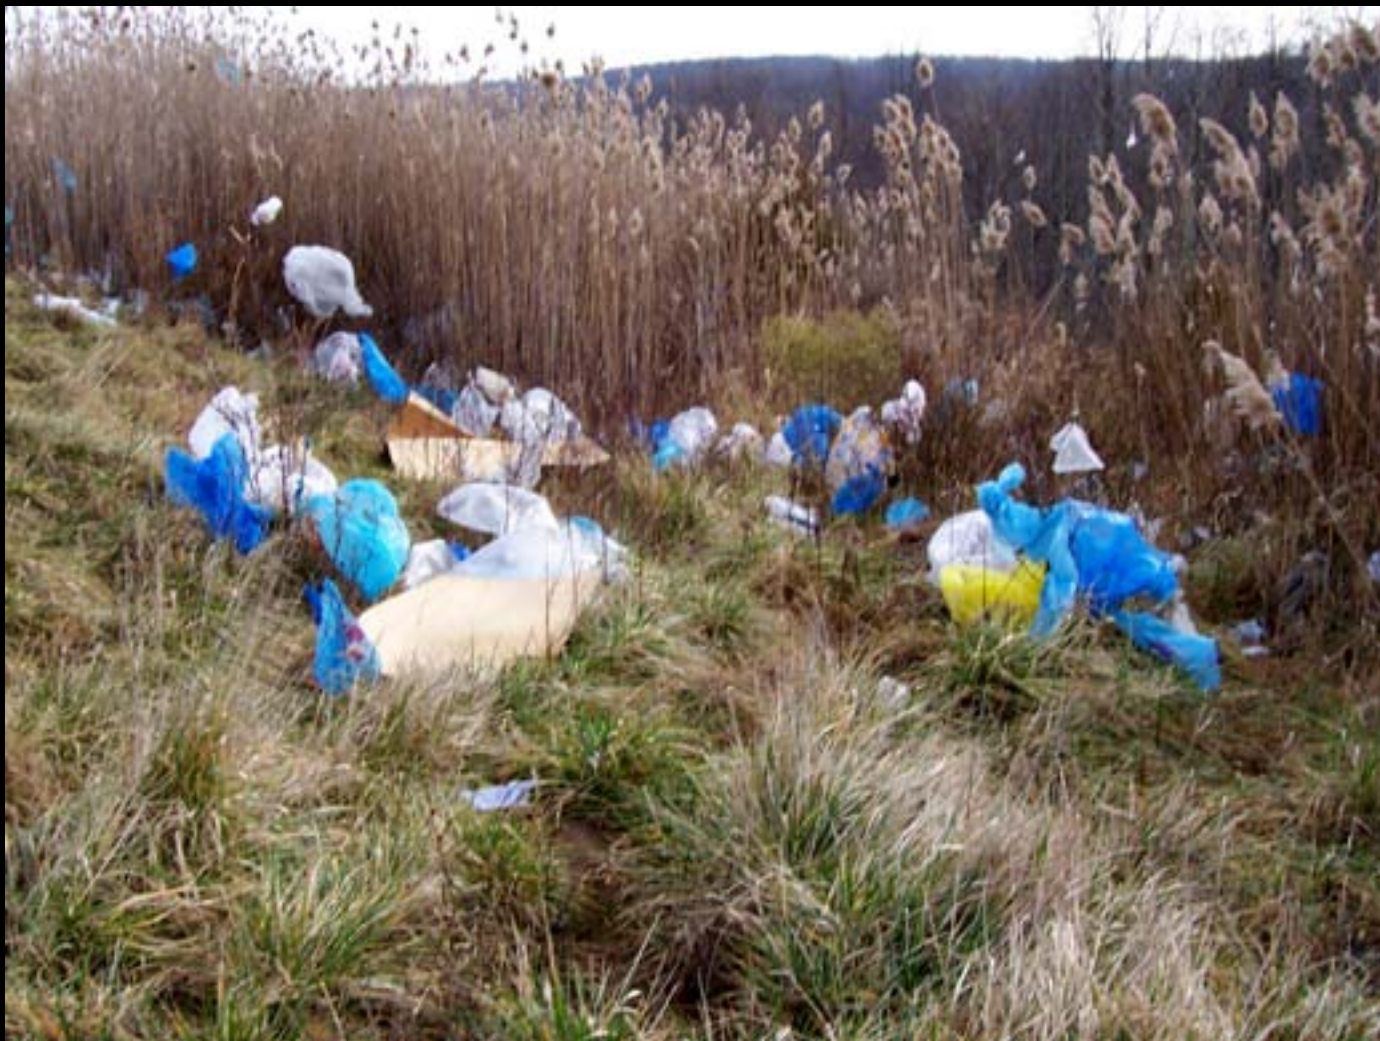
Landfill & Southside Jan 10 2008 016. Exposed garabe - windblown trash.

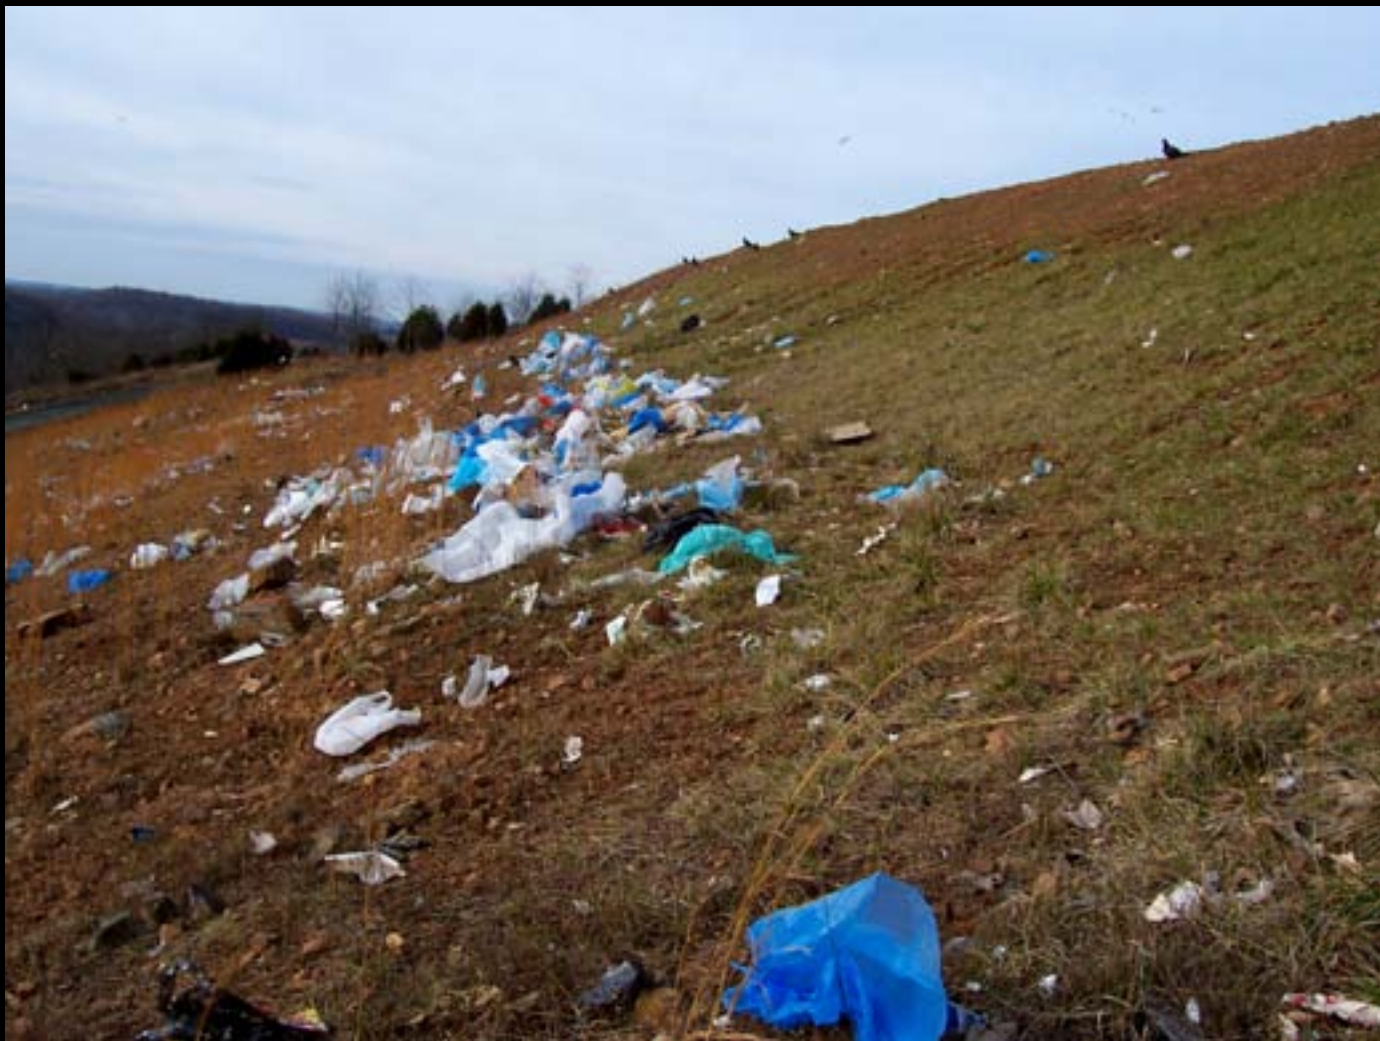
Landfill & Southside Jan 10 2008 017. Southside - windblown trash (approx. 300 ft. in this photo)

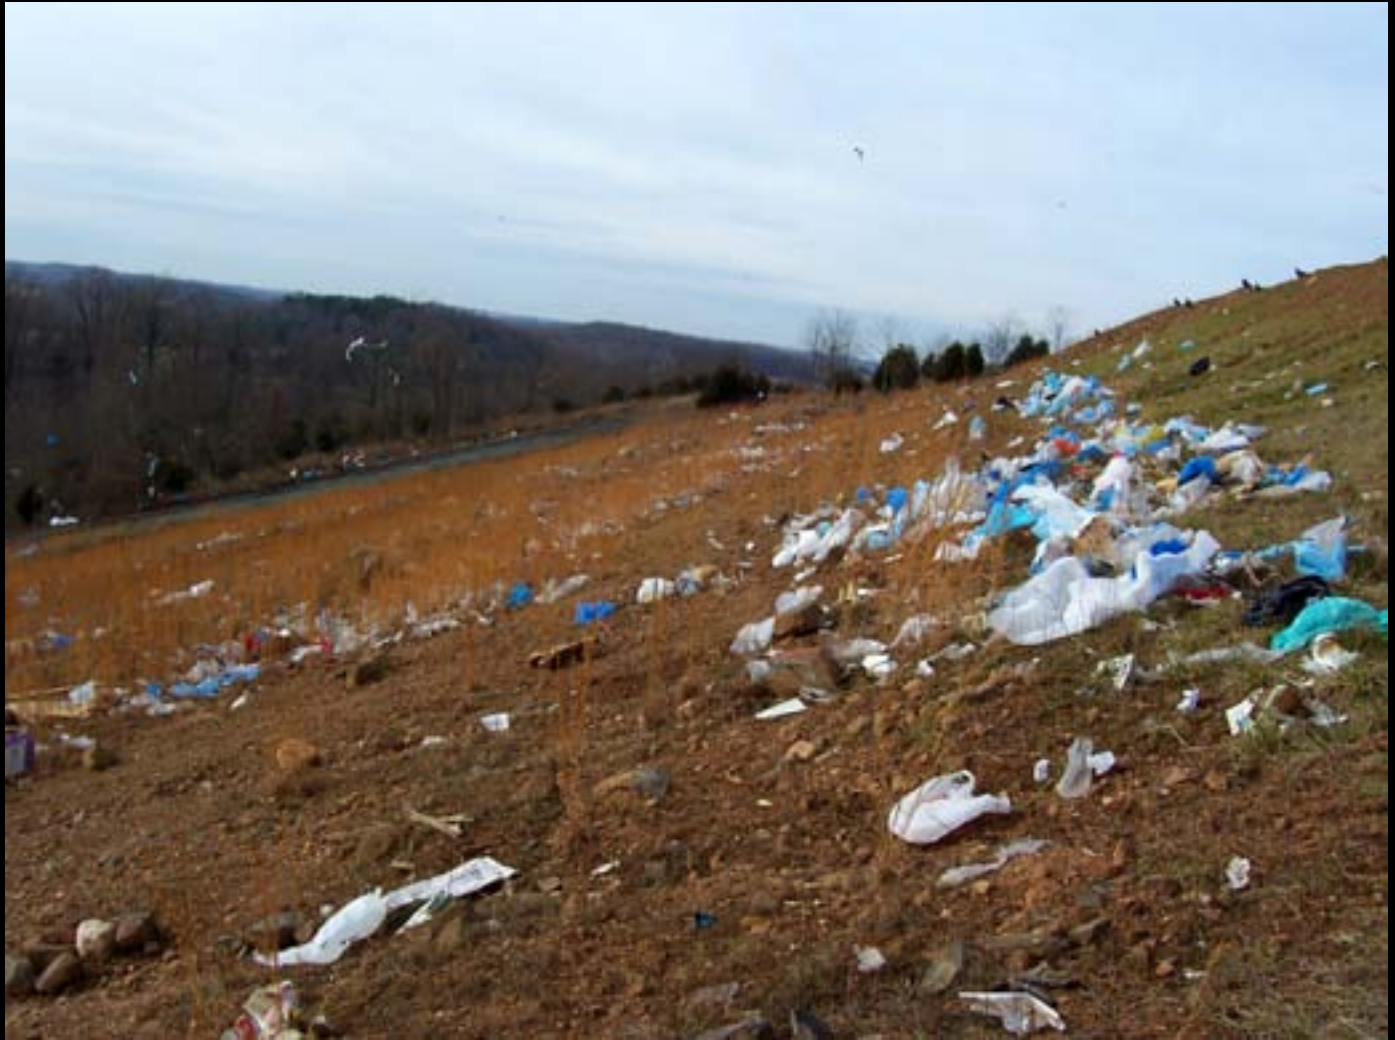
Landfill & Southside Jan 10 2008 018. Southside - windblown trash.

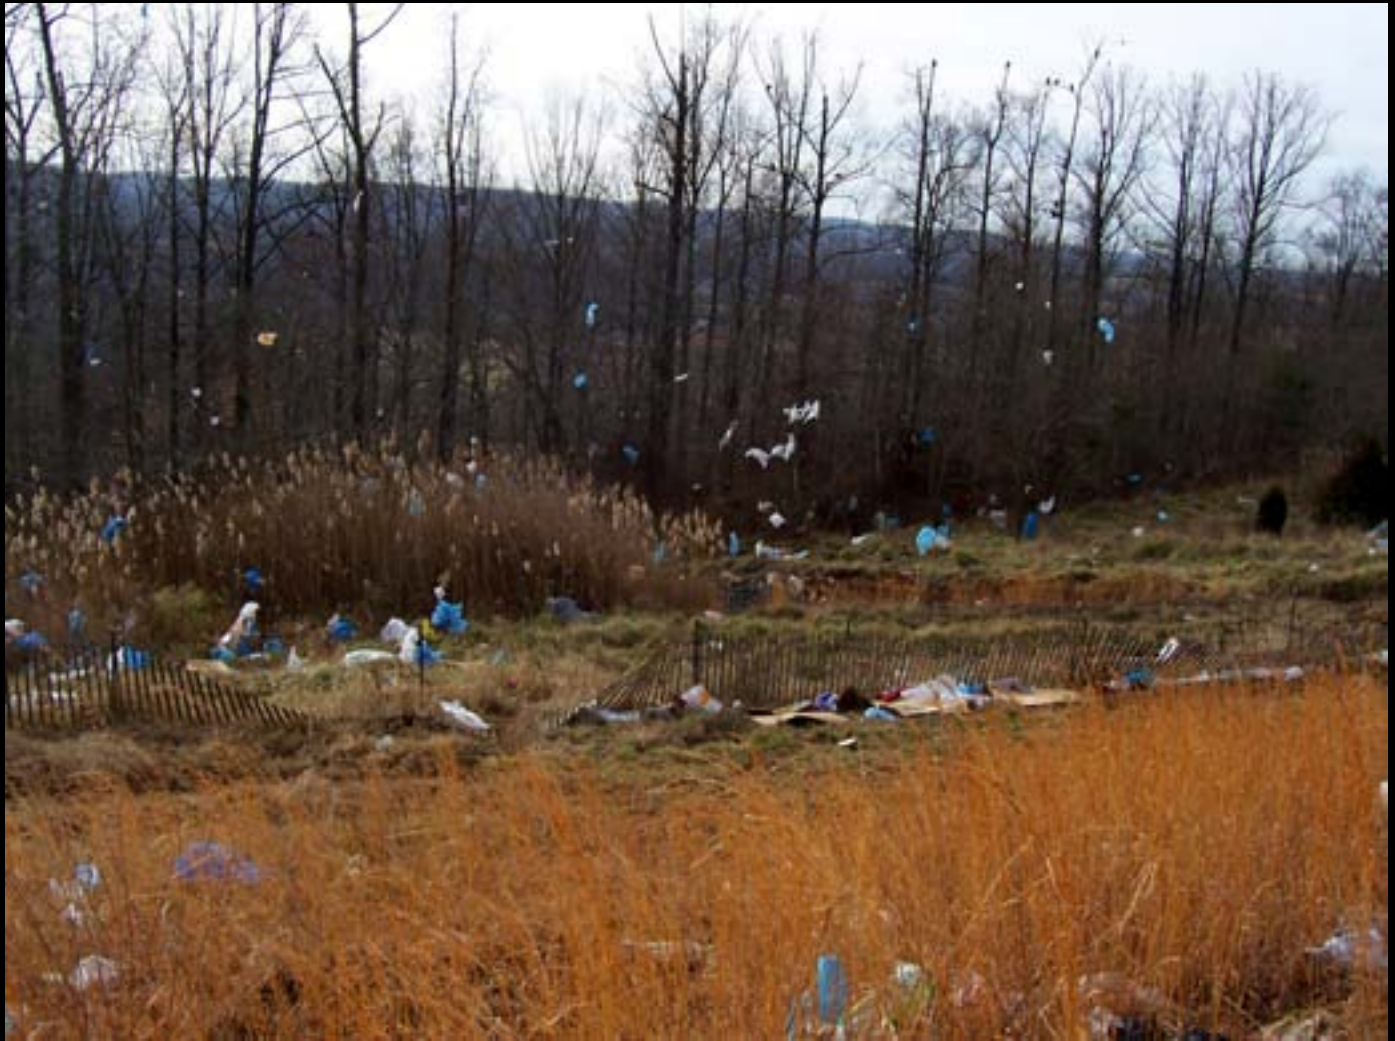
Landfill & Southside Jan 10 2008 019. Southside - windblown garbage on ground and in the trees. Pathetic

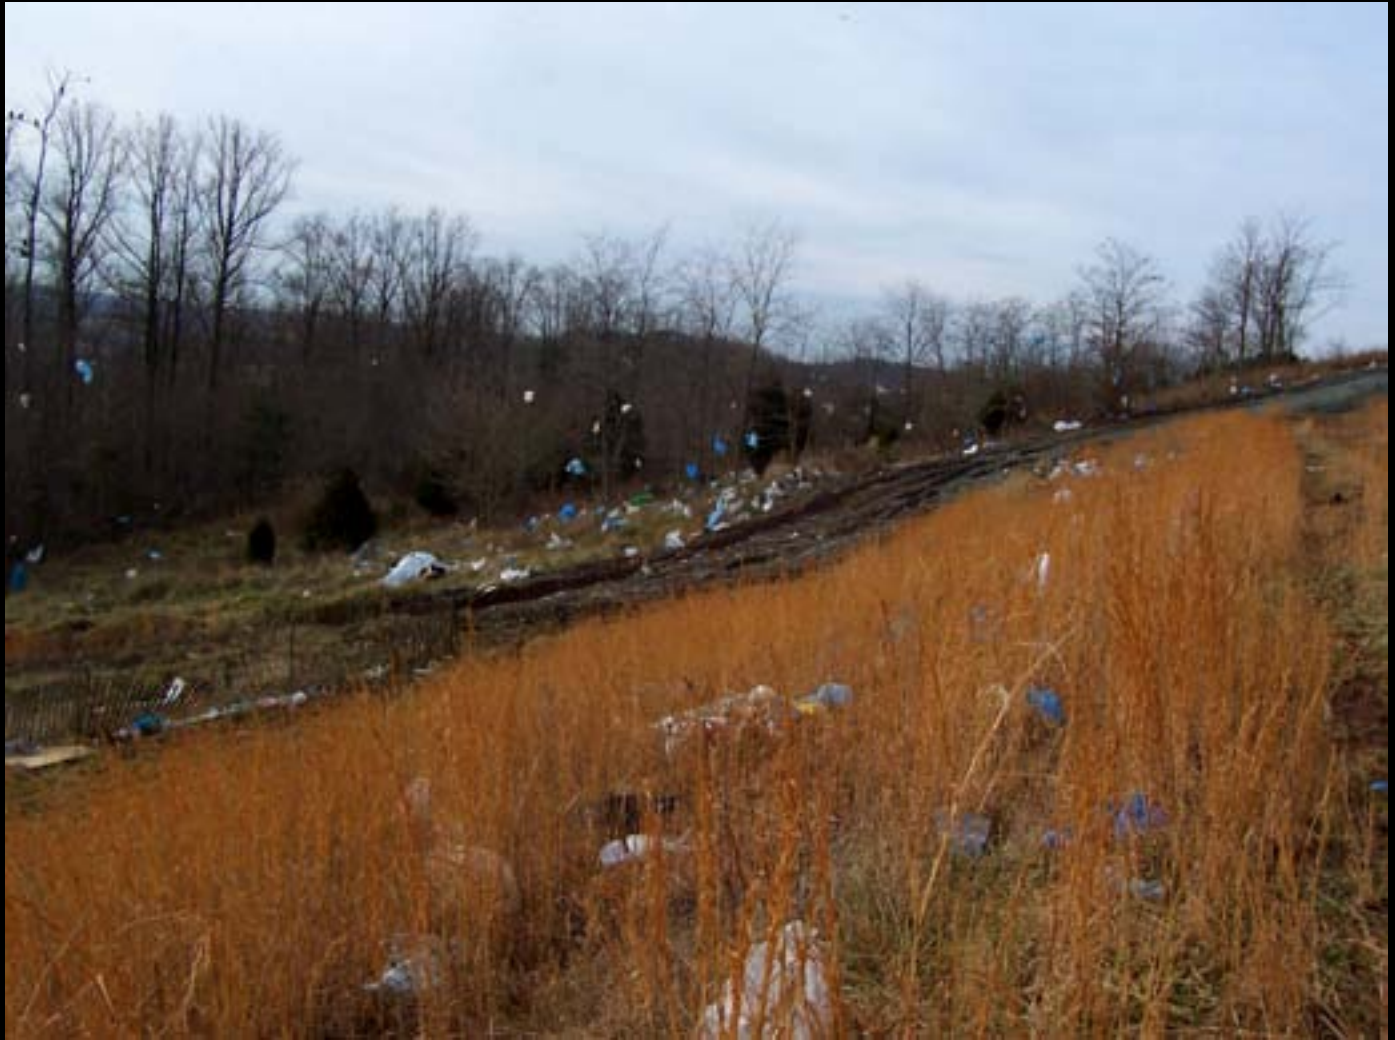
Landfill & Southside Jan 10 2008 020. Southside exposed garbage, and windblown trash

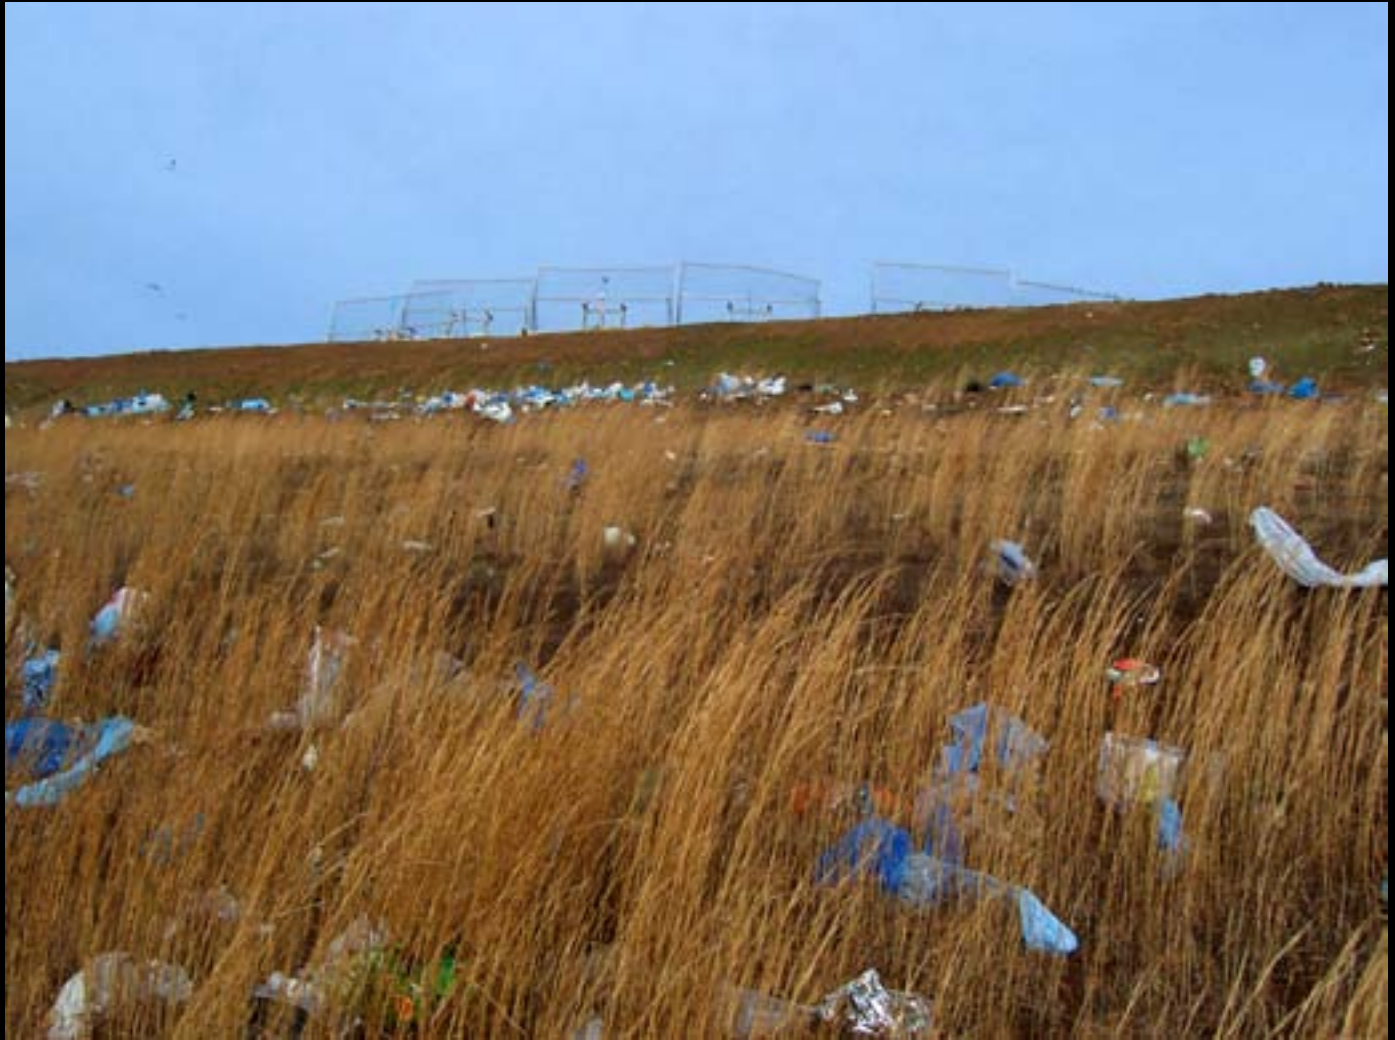
Landfill & Southside Jan 10 2008 021. Southside - windblown trash.
