**Dozens of acres of uncovered trash and other operating permit violations at
Scarboro Landfill, Harford County, MD**

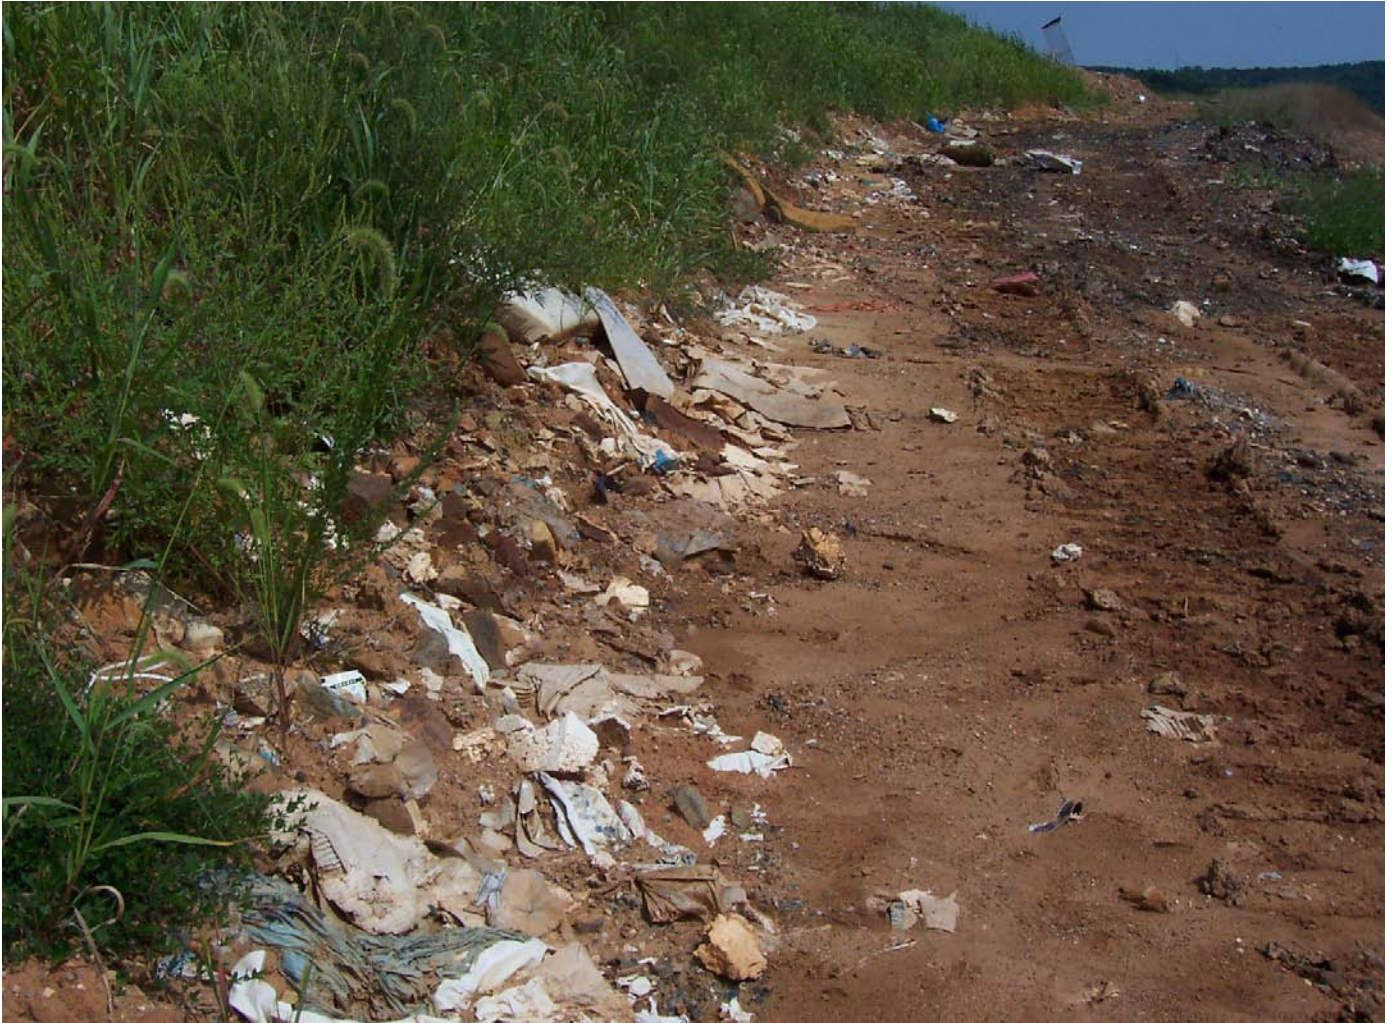
August 29, 2007 Scarboro Landfill south side. Approximately 150 feet of uncovered trash.

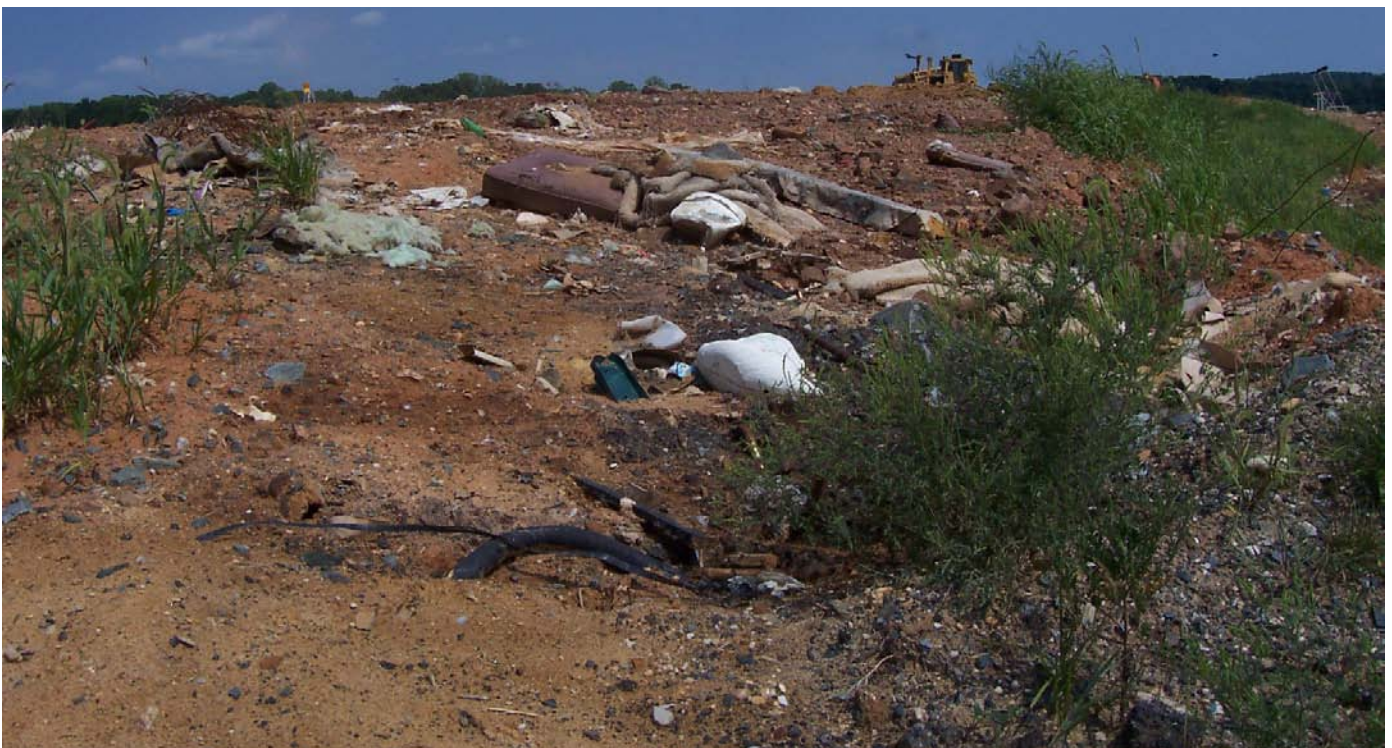
August 29, 2007, Scarboro Landfill south side. Trash never covered – can see workmen at top of ridge – they are working on what can be seen from face – trash just dumped on this side to get out of view.

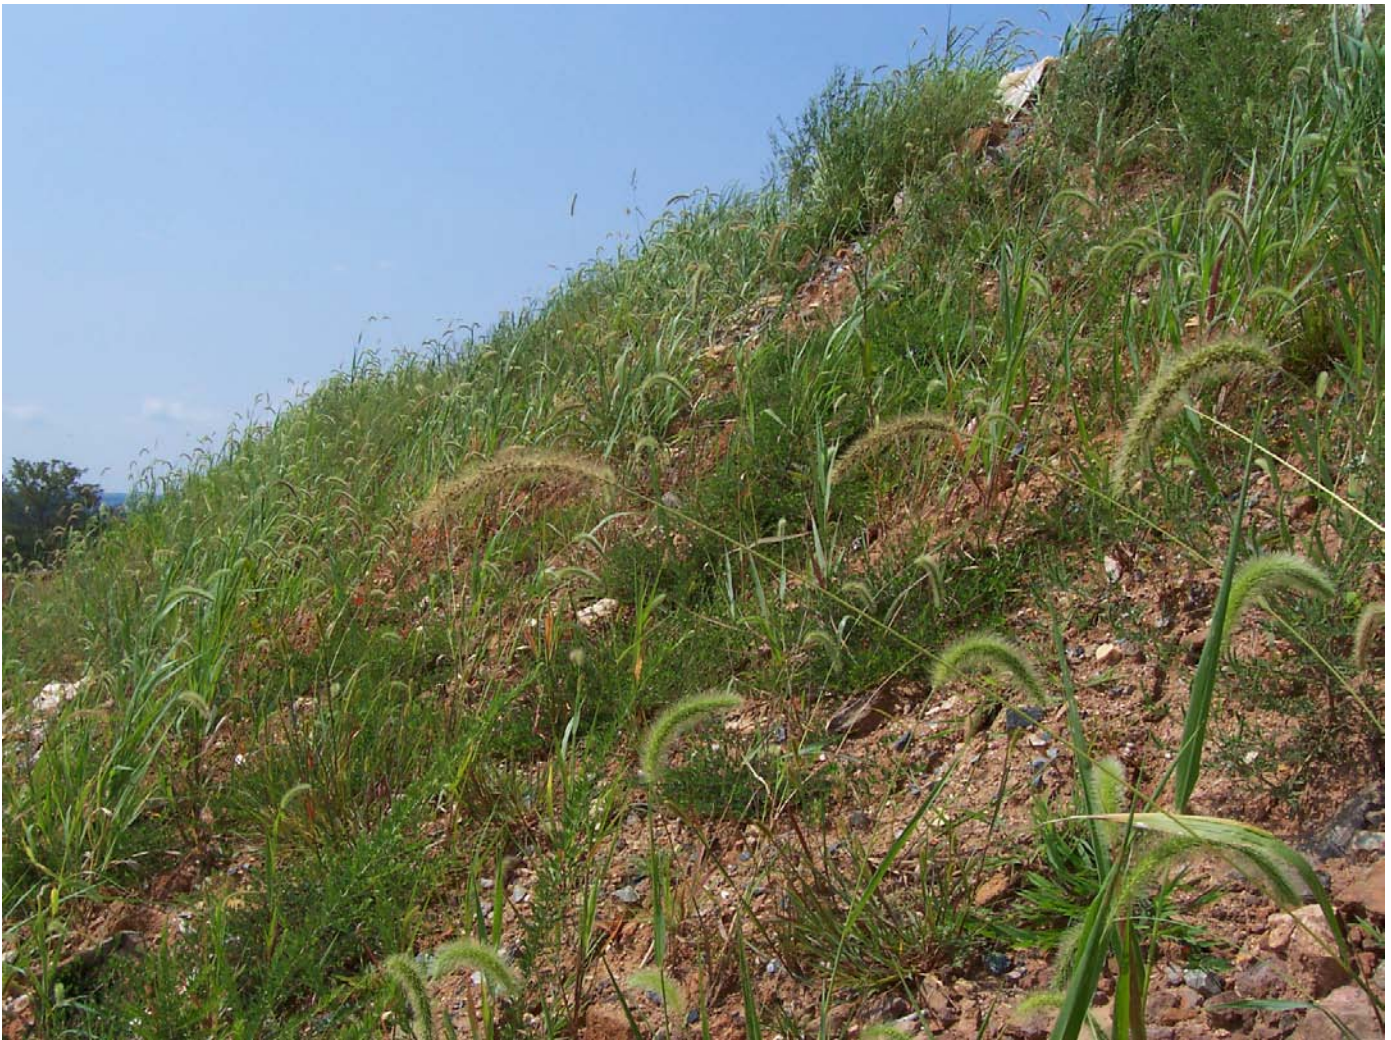
Above, August 29, 2007. Scarboro Landfill south side. Shows steepness of slope. Slope is suppose to be 3:1 this looks approximately 1.5:1 – plus uncovered trash and blown litter.

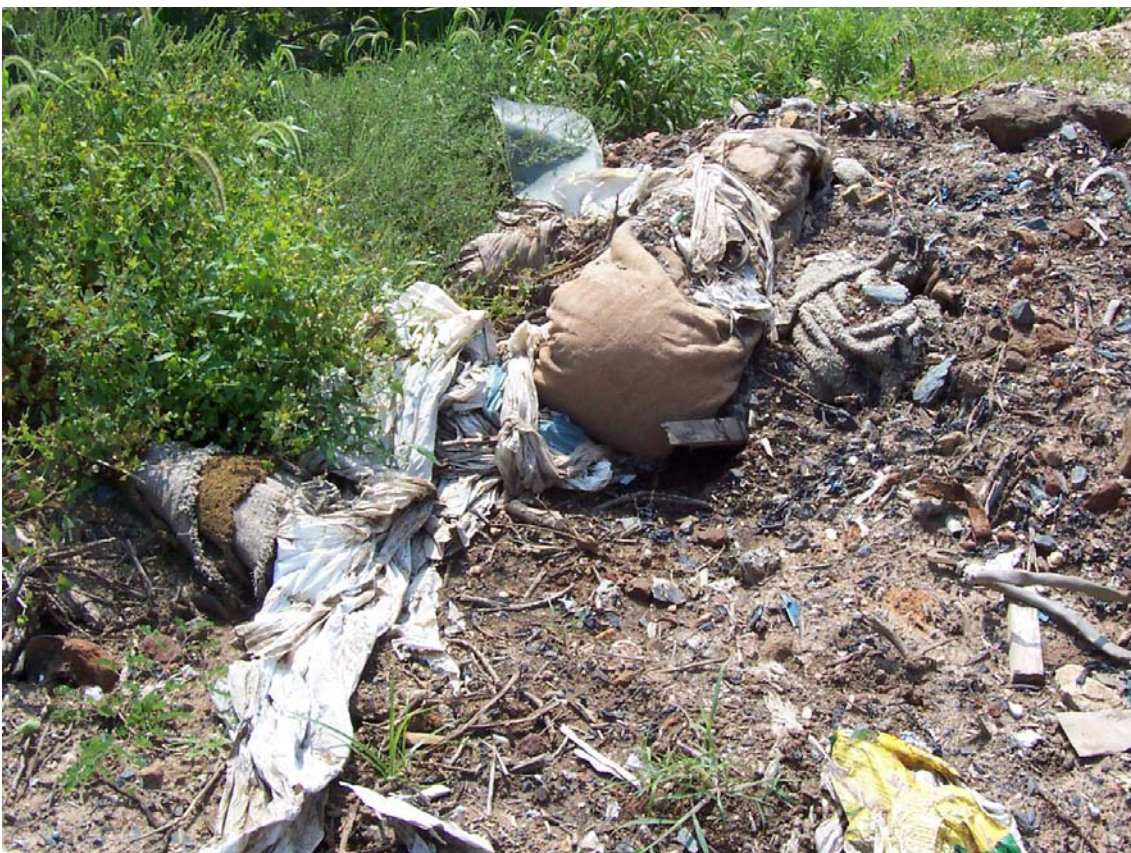
Left, August 29, 2007, Scarboro Landfill south side. Pile of uncovered trash – never covered – mattresses etc.

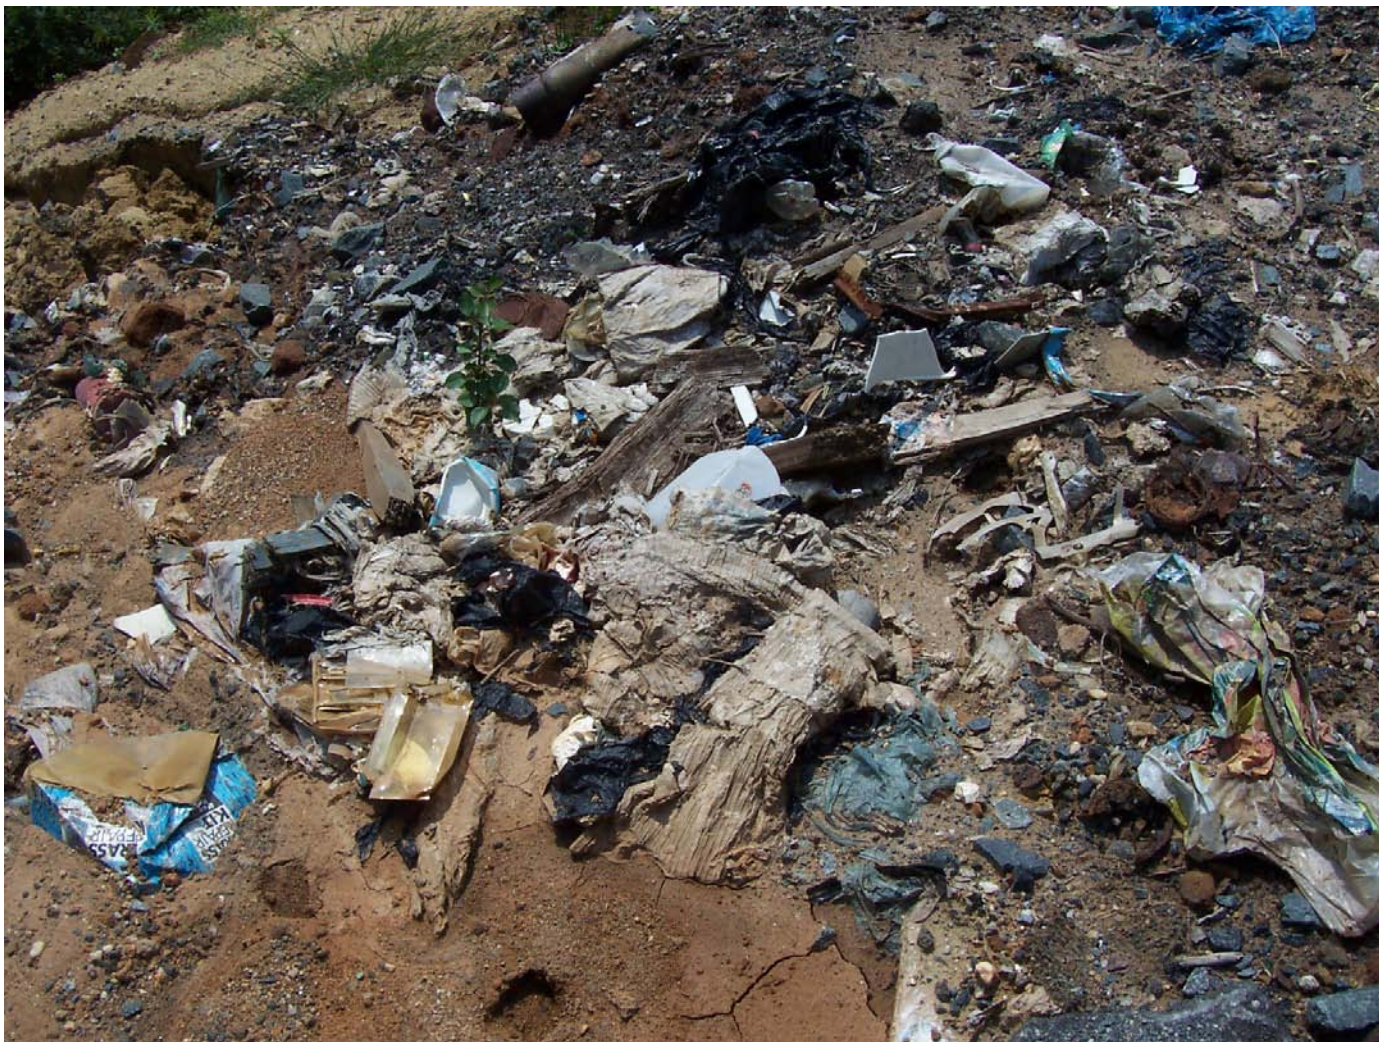
Above, August 29, 2007, Scarborough Landfill south side. Uncovered trash, erosion and spots of leachate.

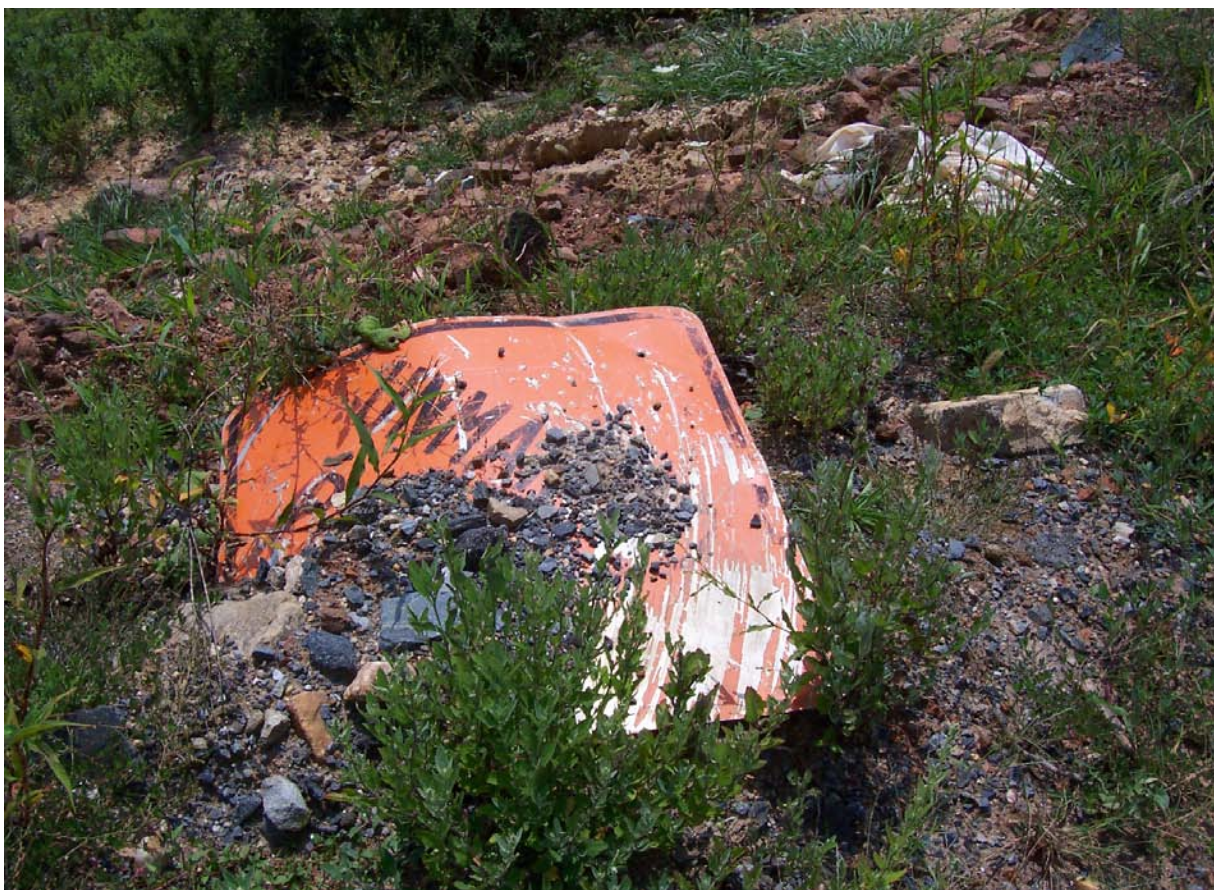
Left, August 29, 2007 Scarborough Landfill south side 013 Metal road sign and other trash never covered just lying in pile with weeds growing all around it.

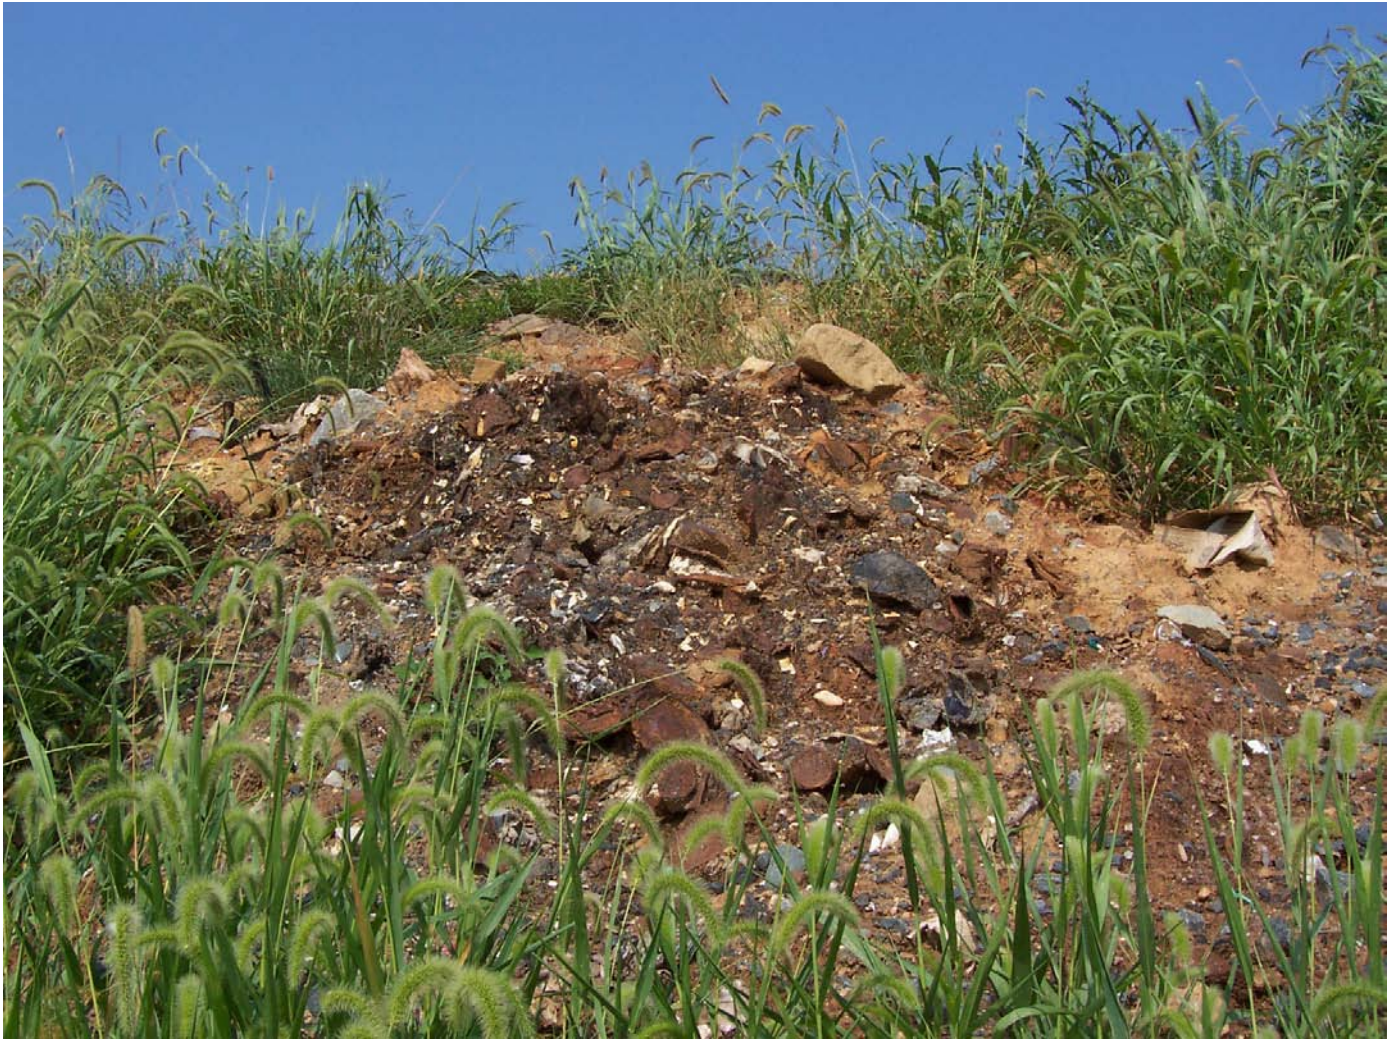
Above, August 29, 2007, Scarborough Landfill south side. Pile of uncovered trash – including metal – just right over bank out of view from face.

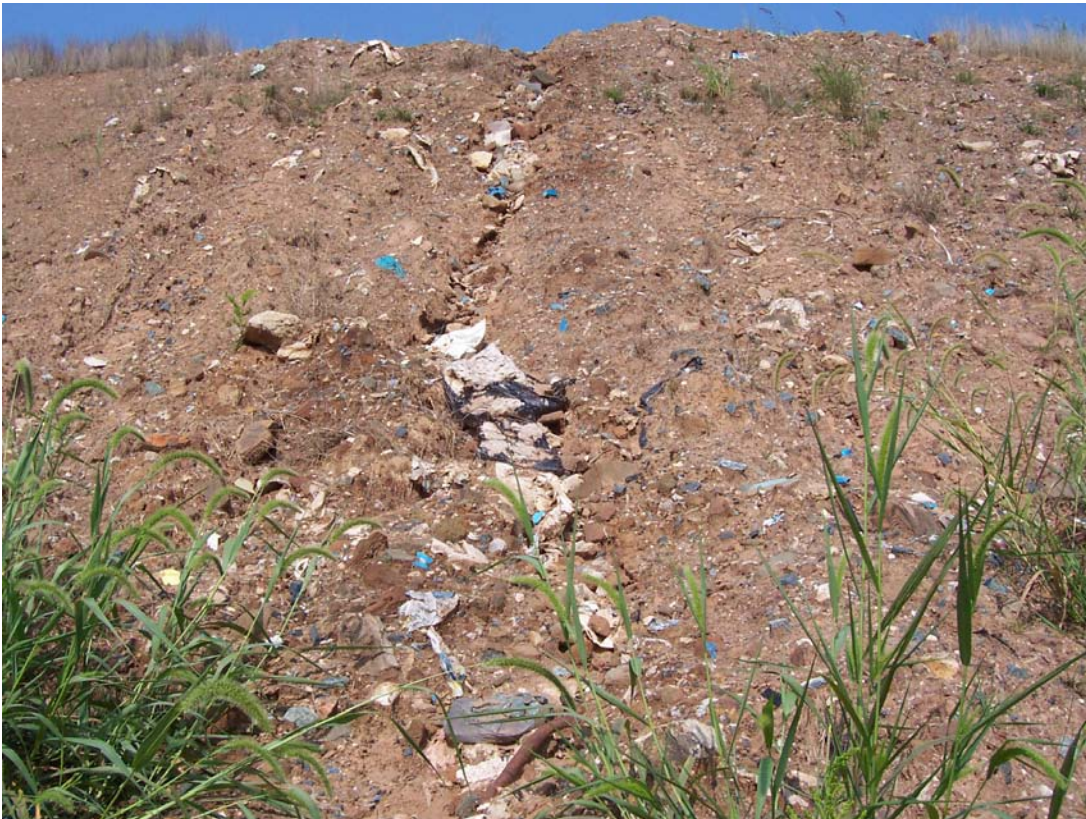
Left, August 29, 2007. Scarborough Landfill, south side. Very deep erosion not stabilized and uncovered trash.
