Scarboro Landfill Permit Violations

Harford County, MD June 7, 2008

Harford County Waste Disposal Center is still blatantly violating its operating permit with Maryland Department of the Environment.

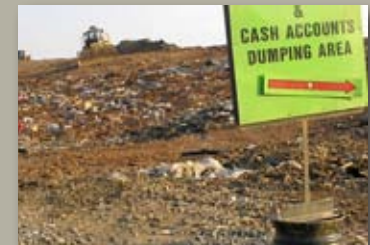
Facing east at top of cell shows new trash dumped over old trash with no attempt to cover or add dirt. Trash includes food, liquids, insecticides with large amounts of maggots and bugs. Foul odor burns membranes. These views are each of different sections over approximately 42 acres at elevation above 450 ft.

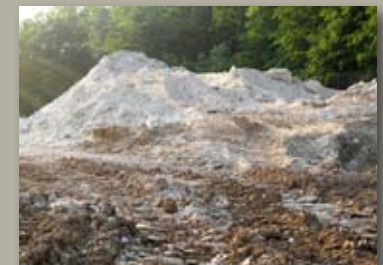
Open leachate, aka
garbage juice

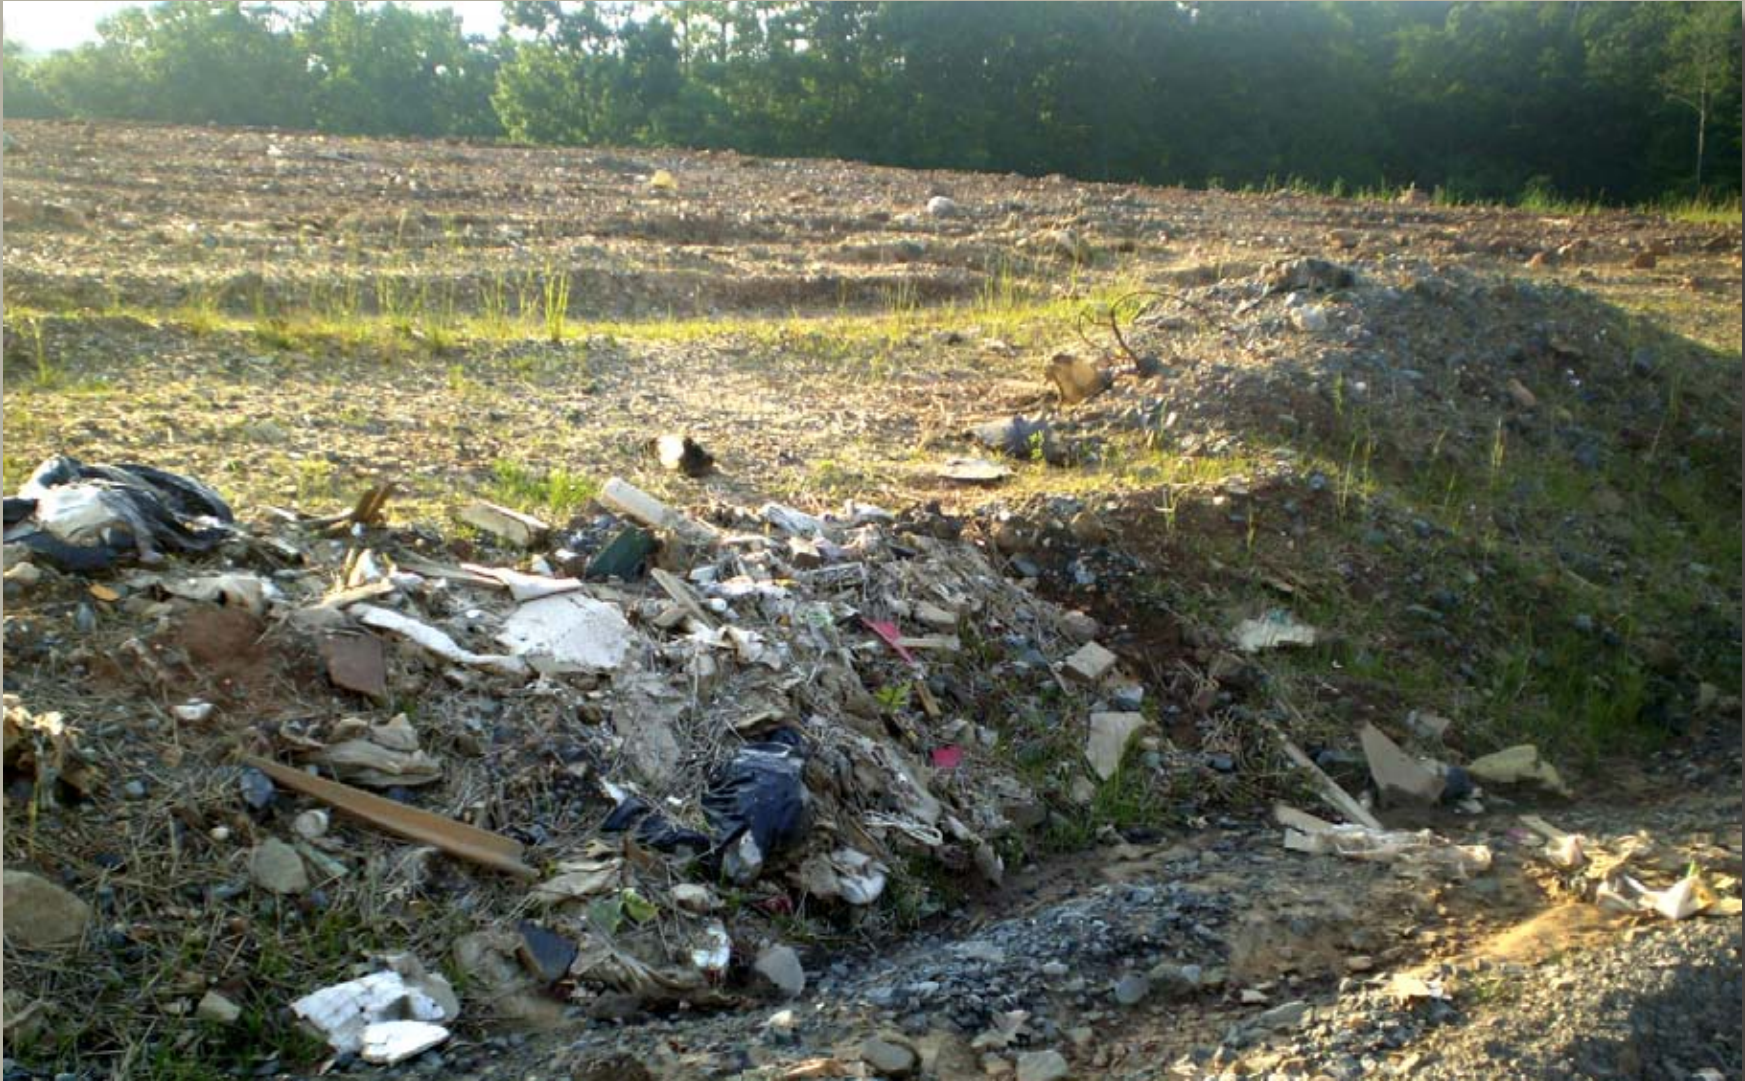
View facing northeast shows no attempt to cover trash at any time as shown by weeds growing through. MDE permit violation open uncovered trash. Evidence of attempted seeding thrown directly over trash. Trash is supposed to have 6 inches of dirt cover at the end of every day and 1 foot intermediate cover after a few weeks.

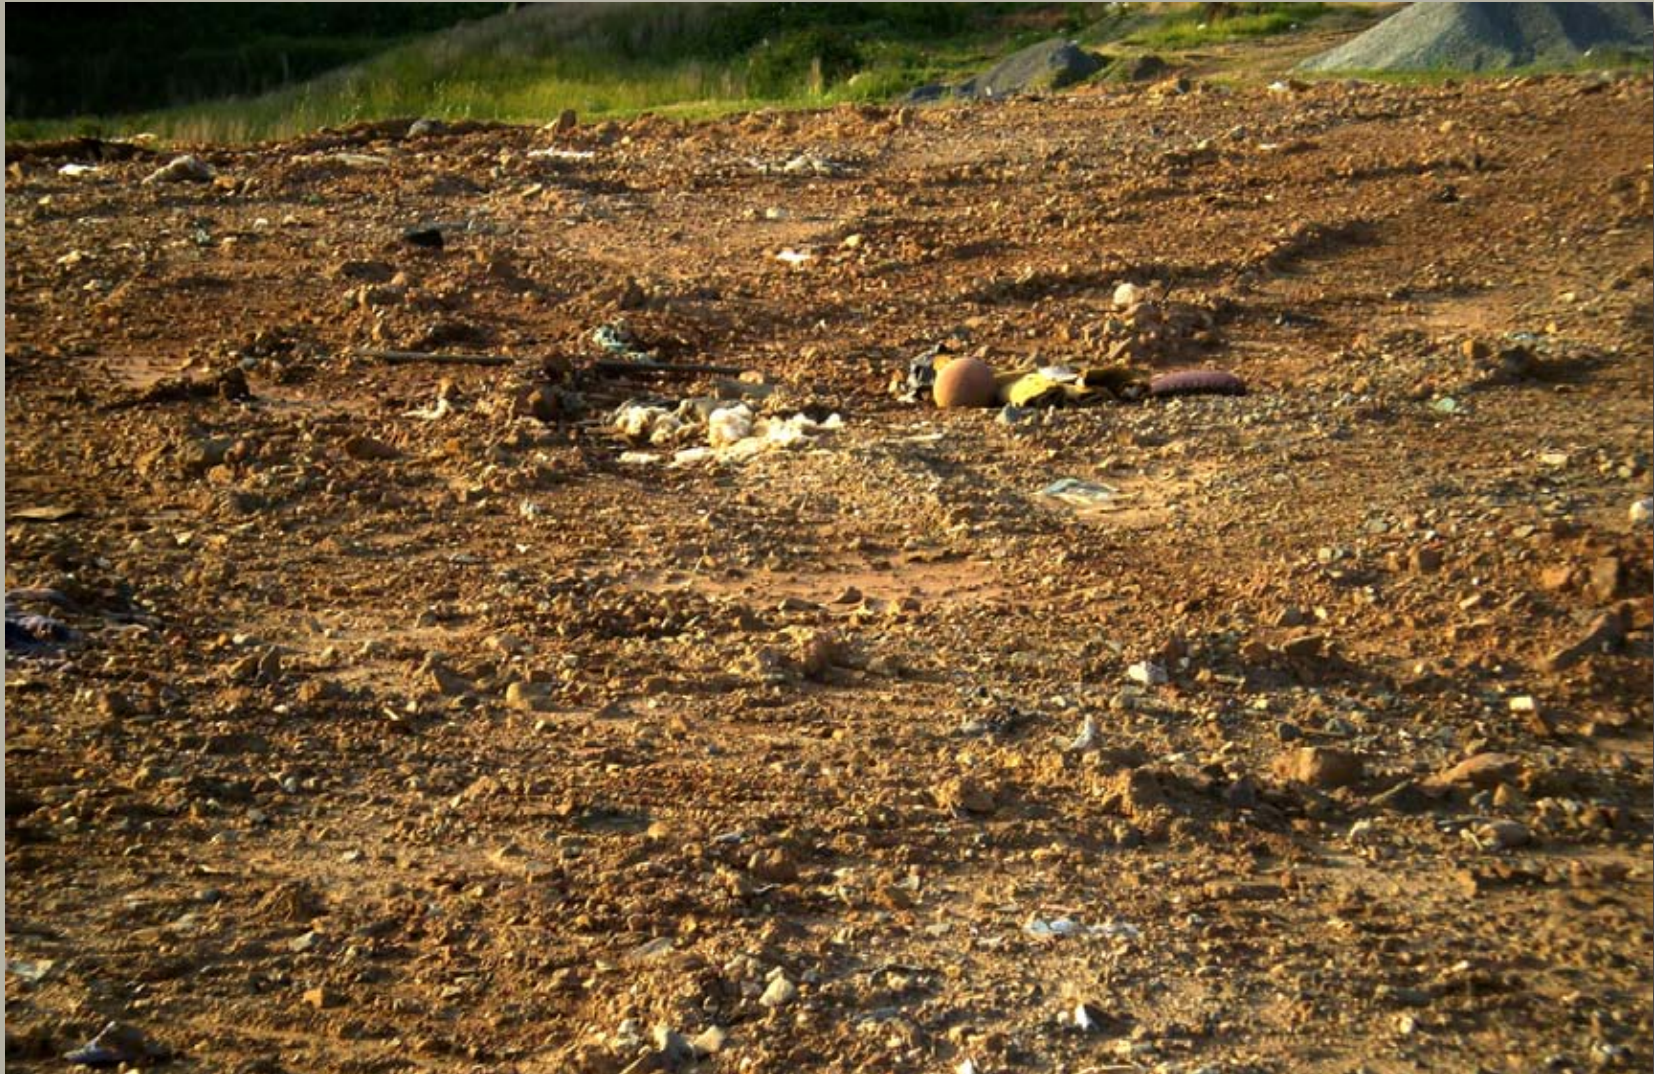
View facing northwest shows minimal dirt smeared into trash. Items in dirt are not rocks--all is trash. MDE permit violation open uncovered trash.

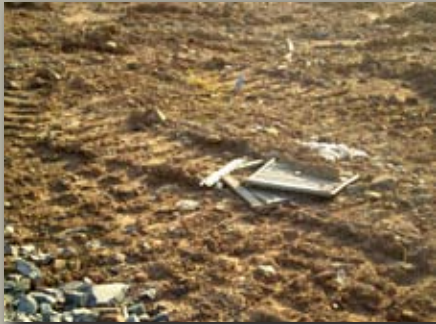
View facing northwest shows ridge trying to cover up view of open garbage from parking lot and Scarboro Rd. MDE permit violation open uncovered trash. Minimal dirt smeared into trash. Items in dirt are not rocks--all is trash.

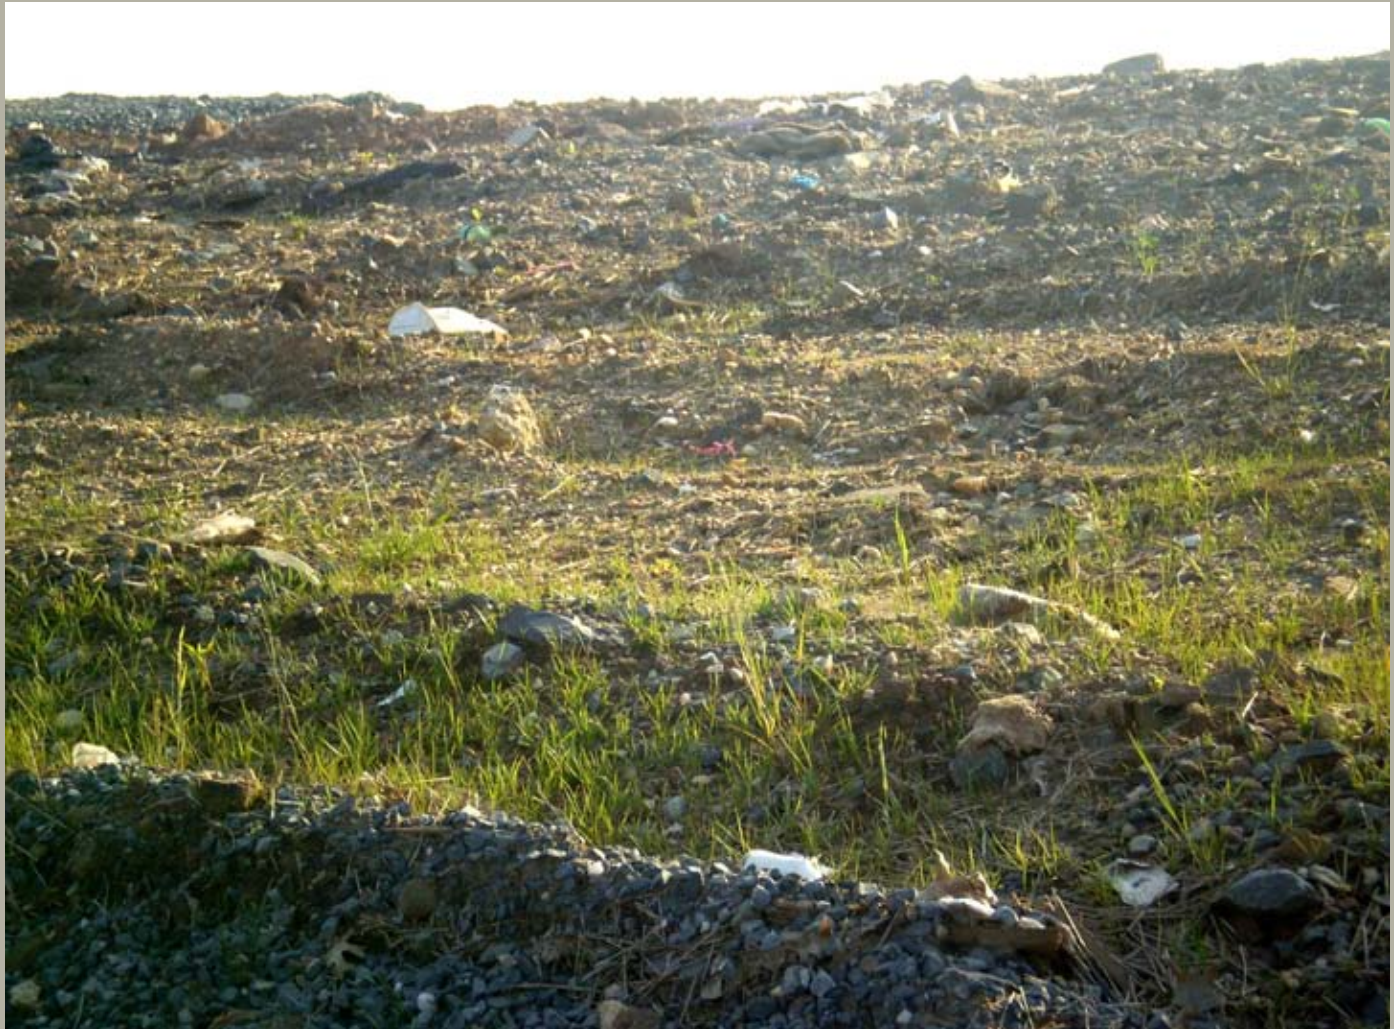
Note weeds growing from trash indicates it's been untouched for many months or years.

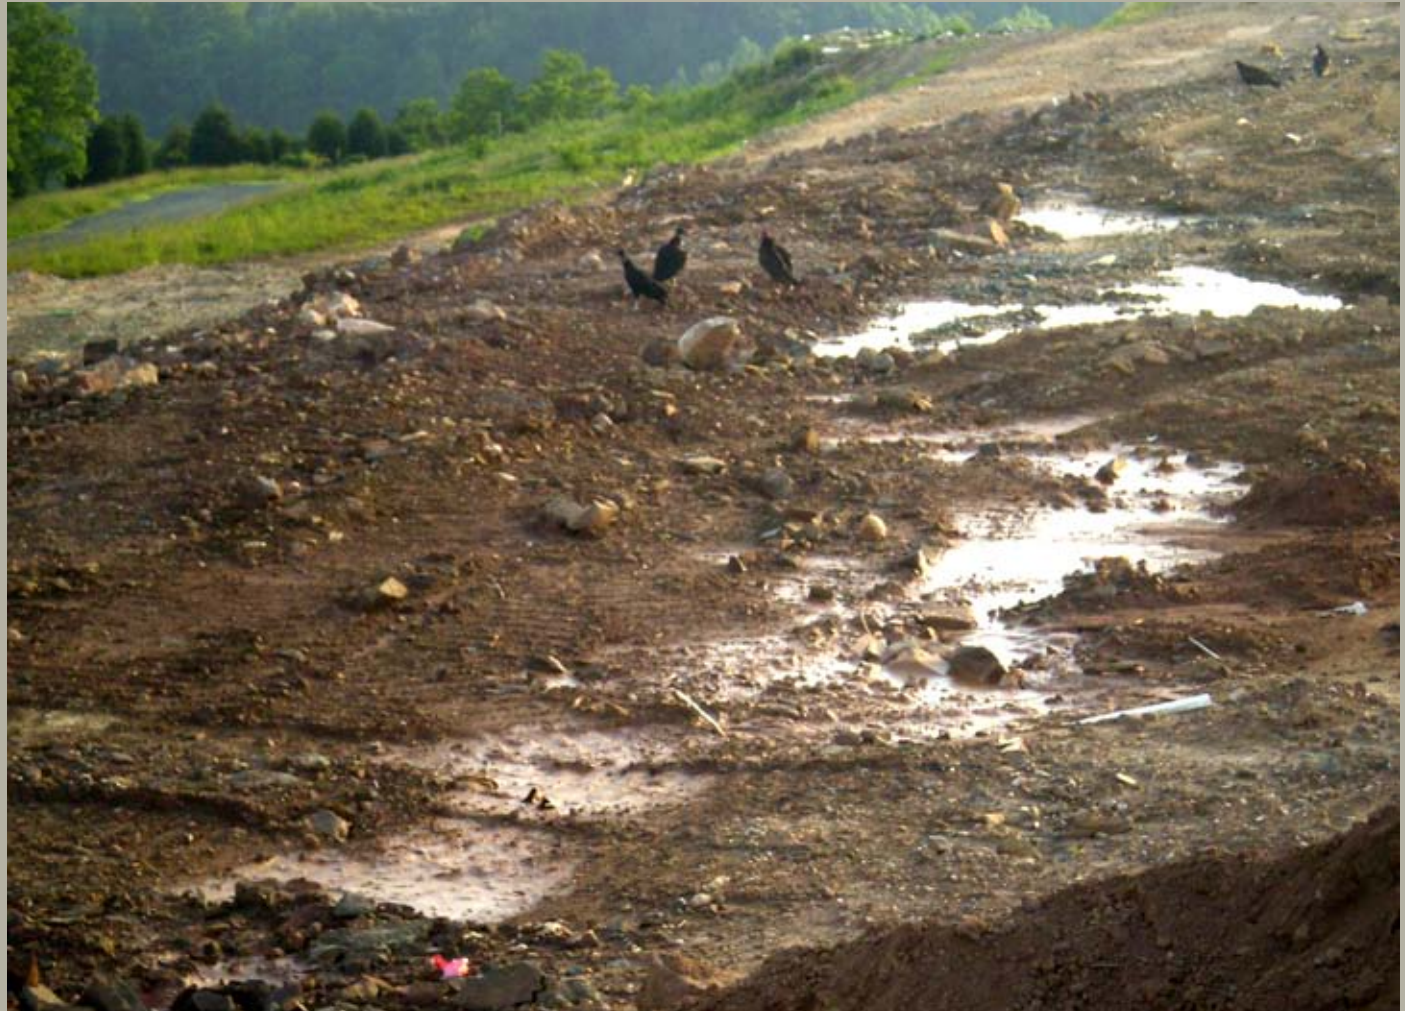
MDE operating permit states leachate (aka garbage juice) is to be drained through a system and removed.

There should be no ponding of leachate on the dump property. Ponding indicates breaks in the liner and poor construction.

These photos show leachate ponding excessively.

Buzzard (aka vectors, also a MDE permit violation) drink from leachate pond. Thousands of buzzards spread miles around the area to residential homes and farms, often attacking pets and cattle and leaving large amounts of droppings.

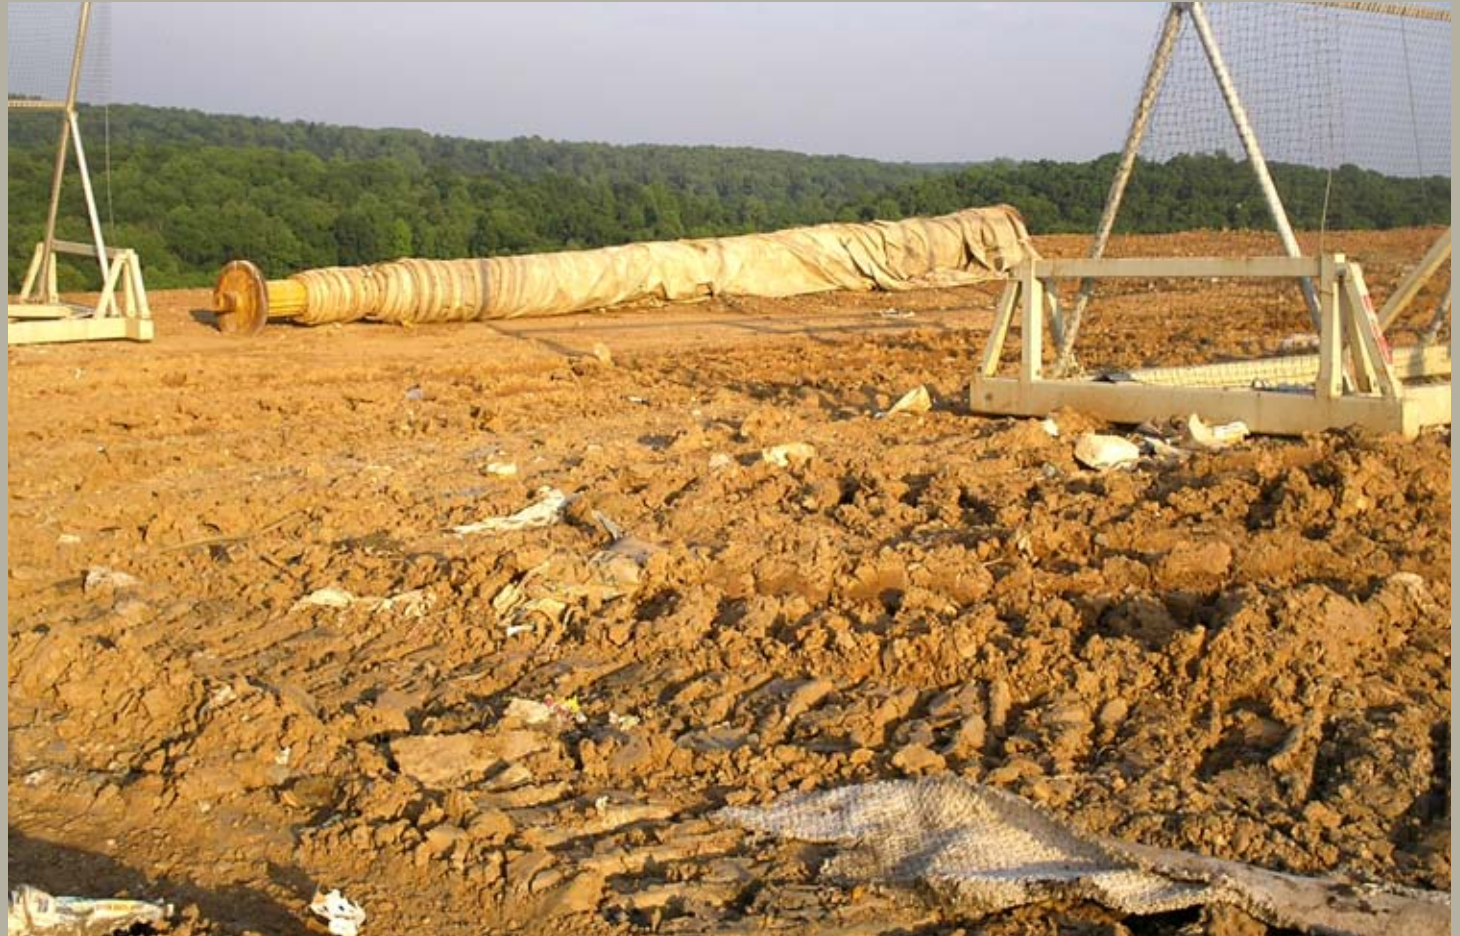
These photos show closeup views of open trash, as seen in the distance photos. Trash and ash (black) dumped from county incinerator mixed together. Also shown is unused tarp, rolled up. Open trash is supposed to be covered with tarp at the end of every day if it cannot be covered with the required 6 inches of dirt. No attempt at temporary cover.

Unused rolled up tarp sits out amidst open trash.

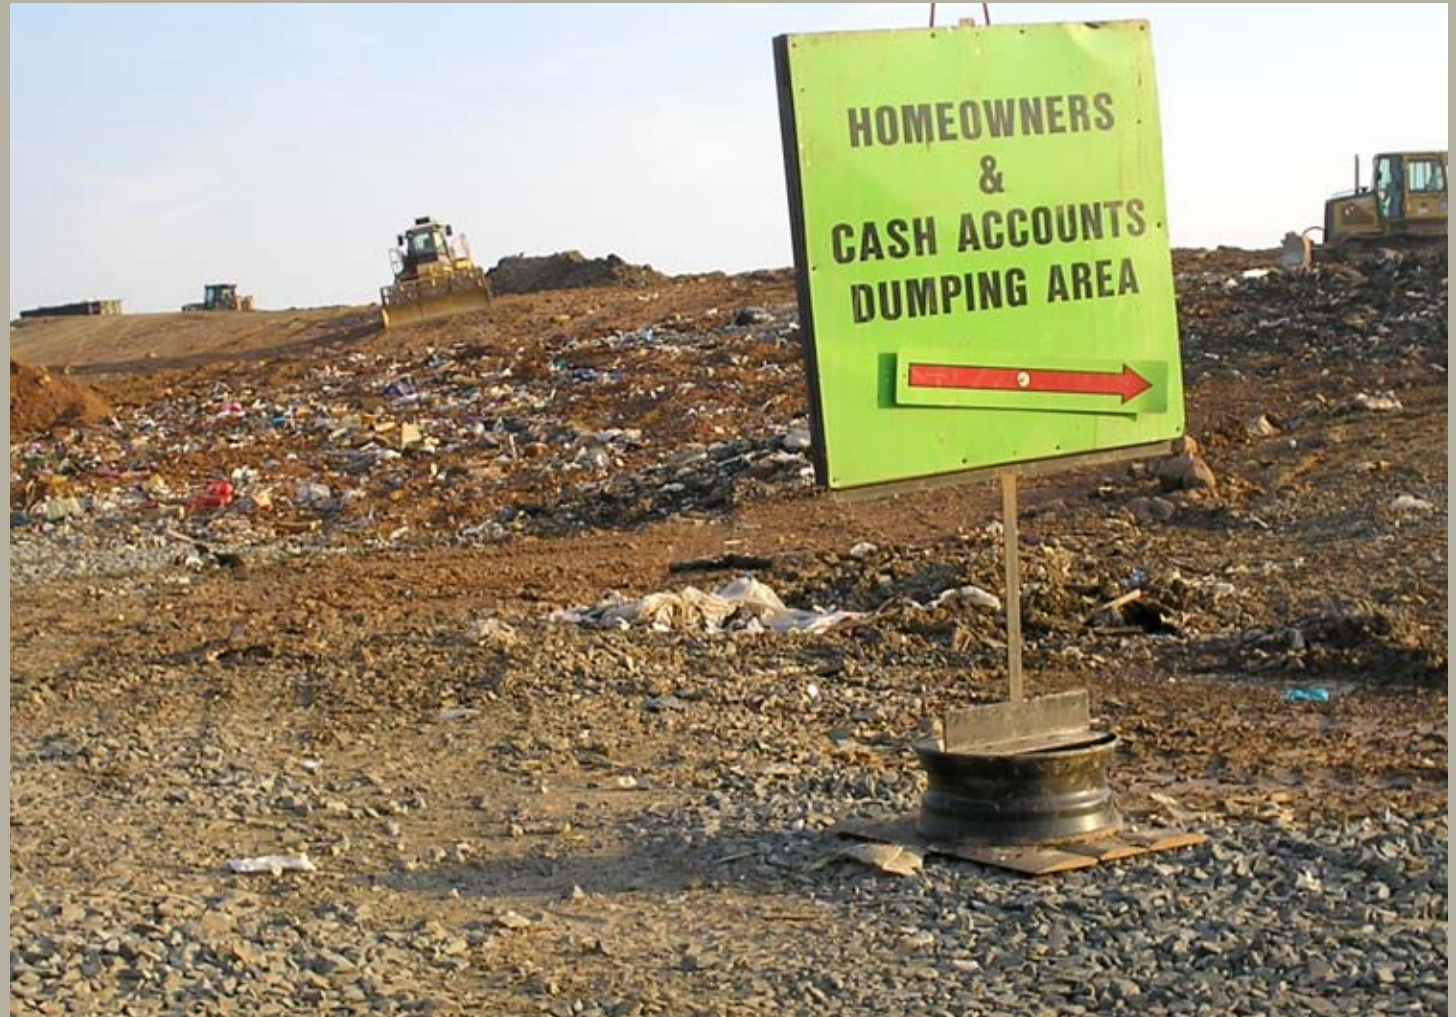
Bulldozers are not operating, the dump is closed. Residents are pointed by sign to dump their own loads. **Anyone can drive there and dump anything, as long as they pay their fees--cash only.**

What exactly do these bulldozers do all day since they don't ever cover the trash with the required daily cover of dirt or even bother to push the trash anywhere? **There is no training of any workers at the dump,** yet another MDE permit violation.

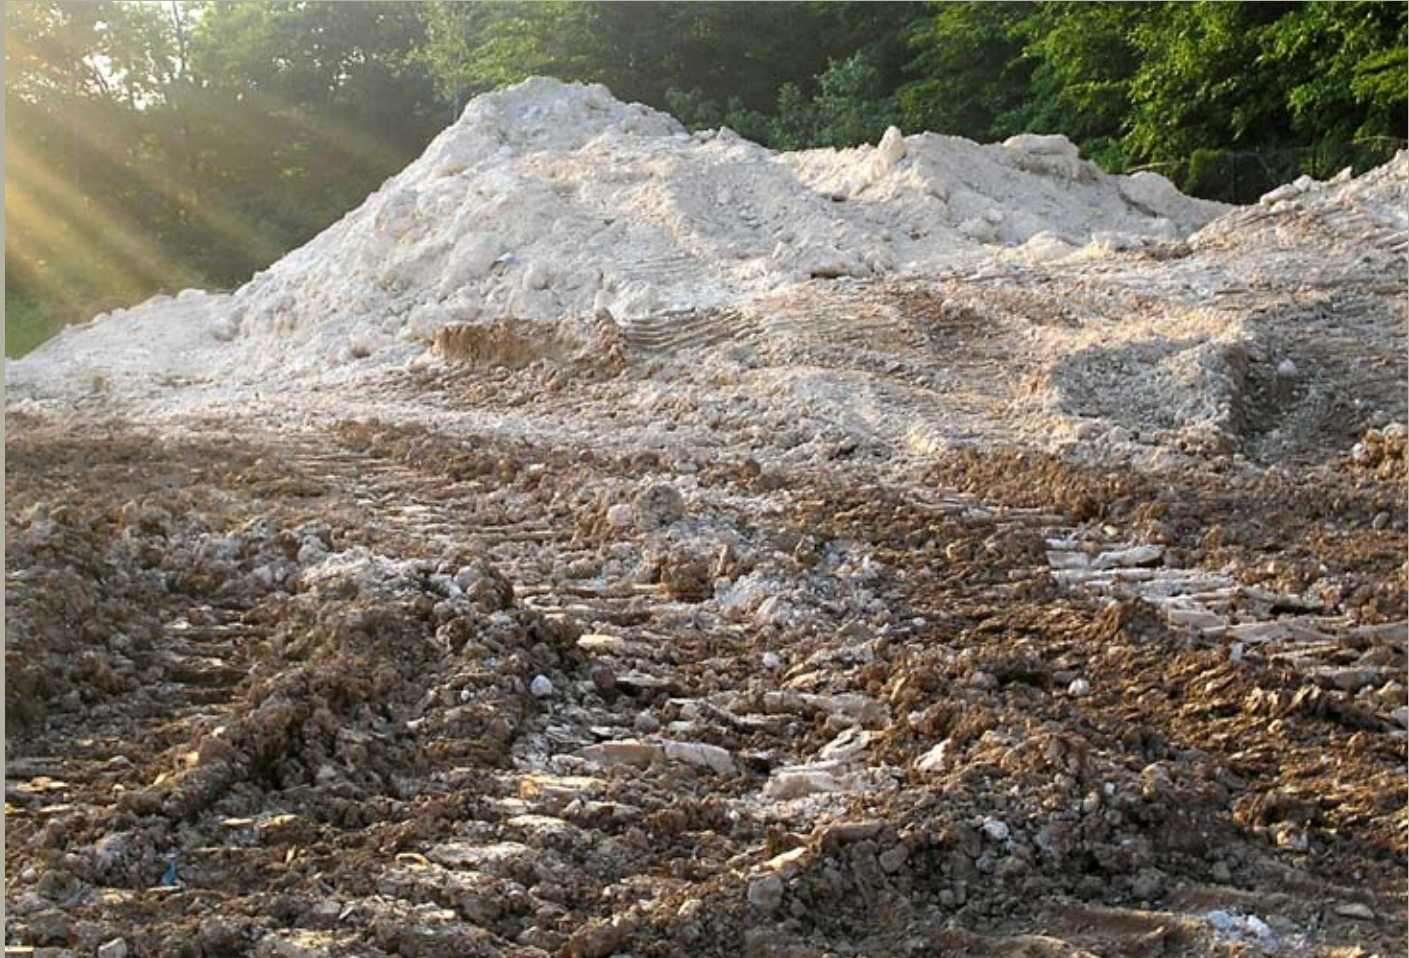
A huge mound of chemical waste from JM Huber of Havre de Grace, MD sits out to blow in the wind. The chemical is silica mixed in toothpaste. **It is a skin and mucous membrane irritant.** Truckloads have been dumped and left to sit out in all areas of the dump for years, as evidenced in the aerial photo taken in Sept 07.
