**Installing the Tarp-O-Matic ADC**

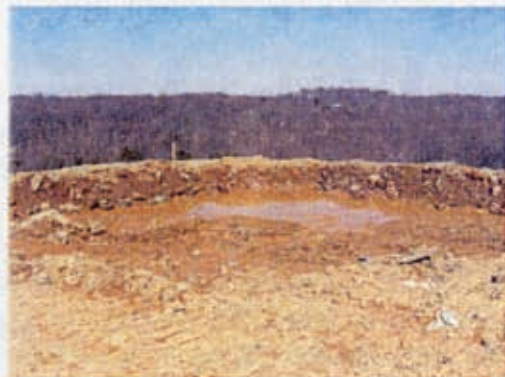
Ponding of water atop the landfill was observed which does not conform to Refuse Disposal Facility Permit No. 2000-WMF-0570 requirements.

**Ponding of Water Atop Landfill**
